We are seeking all documentation connected with the TG1900 Tower Crane Accident SN 76G9-1206C CD3705 that was involved in the February 16th, 2012 crane accident at the World Trade Center Tower 4 Project. Specifically we are seeking a copy of the report generated by Dr. Haag at the request of the Port Authority.

World Trade Center 4500063211
4 World Trade Center
New York, NY
Client File: 4500063211
Haag File: 0212001176-250

The Port Authority of NY and NJ
Port Authority Safety Board
225 Park Avenue South 15th Floor
New York, NY 10003

December 21, 2012

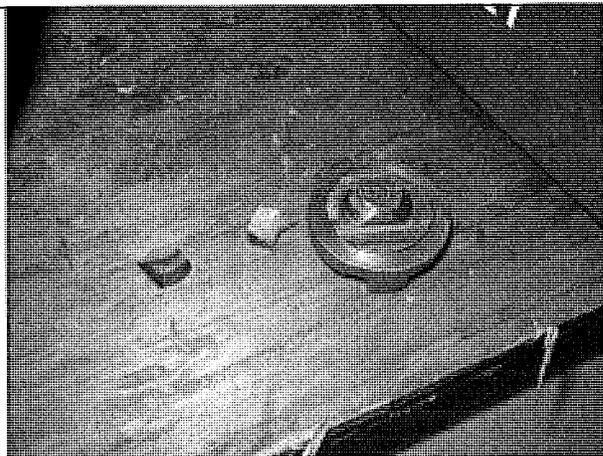
Broken Oldham's coupling

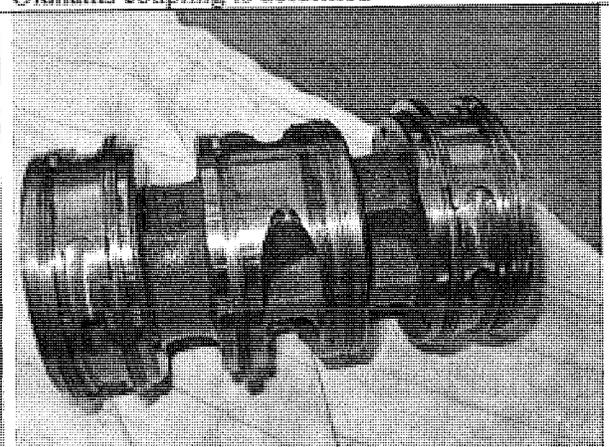
Spool is galled and discolored by heat

The galling of the distributor is likely the result of a lack of lubrication, which is often caused by cavitation or over speeding of the motor. If the motor is starved of oil and there is no oil flowing out, the motor can spin without control. Starved of lubrication, the spool will seize in the bore and lock. In this case, the drive coupling was damaged, but not completely broken.
