Torres Rojas, Genara FOIA 13078

ASBESTOS ABATEMENT ACTIVITIES

TO: Henry Howie, Resident Engineer, JFK
FROM: George A. Jensen
DATE: May 30, 1991
SUBJECT: JFK - ASBESTOS ABATEMENT FOR AMERICAN AIRLINES TERMINAL BUILDING #57
REFERENCE: JFK-215.550 Asbestos Renewal via Work Order
COPY TO: B. Abramowitz, K. Apgar, S. Benjamin, G. Ciana, C. Clancy, S. DeLuise, J. Giordano, R. Peduto, R. Raczynski, [redacted], L. Vernon

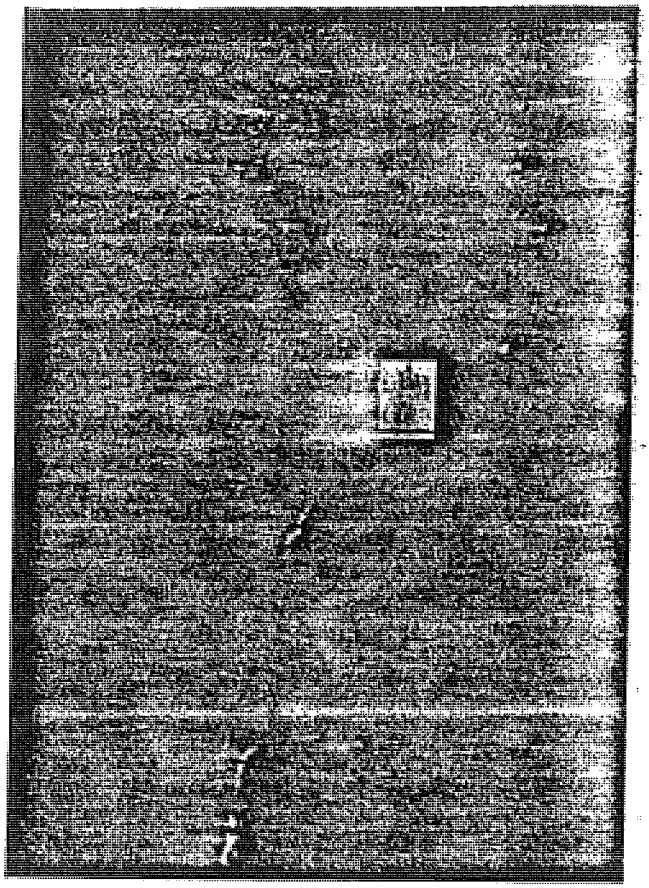
Picture #	Description
1	West Warehouse, damaged wall material.
2	West Warehouse, space heater, exhaust pipe insulation.

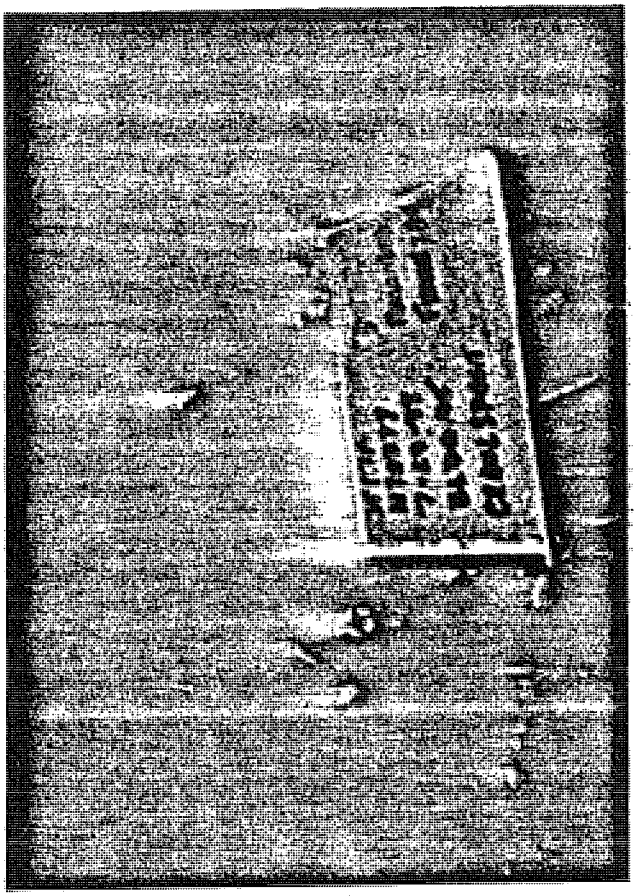
Picture #	Description
1	Flight simulator, crawl space, debris.

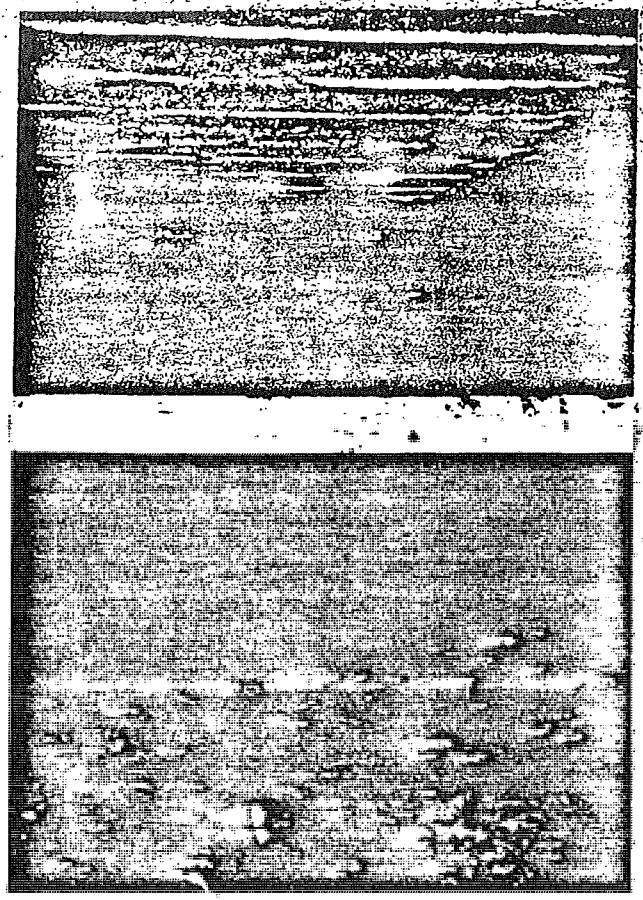
Picture #	Description
1	Ground Floor, unexcavated crawl space and debris.
2	Ground Floor, Kitchen Mechanical Room, damaged duct insulation.
3	Ground Floor, Kitchen Mechanical Room, water actively leaking on duct, damaged pipe insulation.
4	Ground Floor, Kitchen Mechanical Room, debris on floor.
5	Ground Floor, North Mechanical Room, damaged duct insulation and debris on floor.
6	Ground Floor, North Mechanical Room, damaged duct insulation upper surface of duct.
7	Ground Floor, Kitchen, food preparation area, damaged pipe insulation.
8	Ground Floor, Garage Area, asbestos rope packing above doorway to warehouse.
9	Ground Floor, Boiler Room, storage area, stored gasket material.
10	Ground Floor, Boiler Room, storage area, debris.
11	Ground Floor, Boiler Room.
12	Ground Floor, Chiller Room, damaged tanks.
13	Penthouse, Office, wall area.
14	Penthouse, North Mechanical Room, damaged piping.
