List of specific record(s):
Please provide any and all reports generated by Haag Engineering related to the February 16th, 2012 crane accident on the World Trade Center Tower 4 Project, involving the TG1900 Tower Crane SN 76G9-1206C CD 3705

World Trade Center 4500063211
4 World Trade Center
New York, NY
Client File: 4500063211
Haag File: 0212001176-250

The Port Authority of NY and NJ
Port Authority Safety Board
225 Park Avenue South 15th Floor
New York, NY 10003

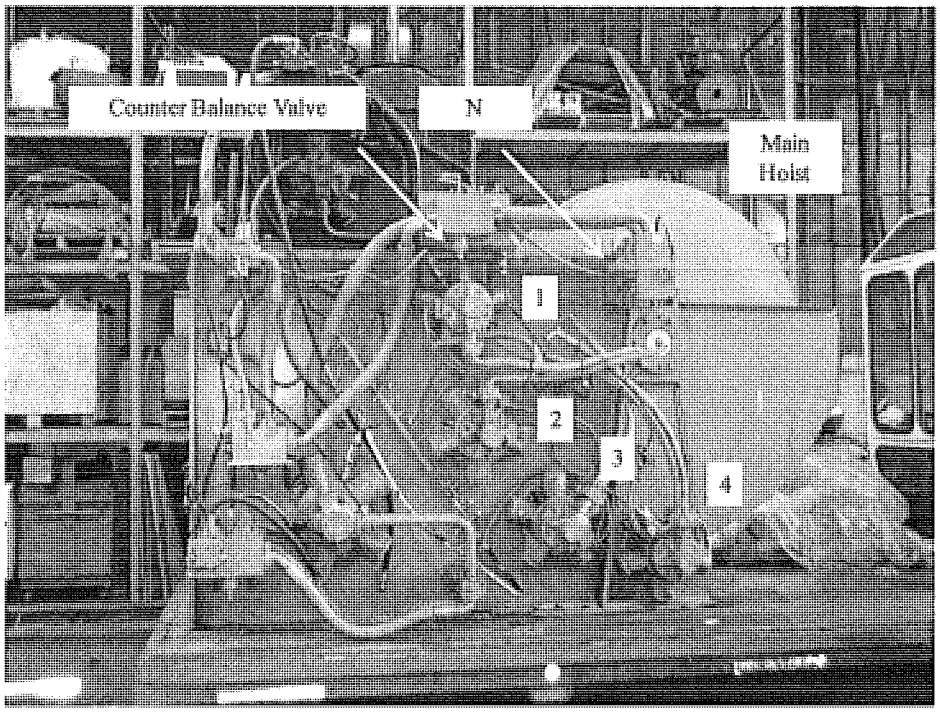
***Descriptions.*** Figure 1 shows a labeled photograph of the crane hoist system before the hydraulic components were removed and inspected at Federated Crane on March 1, 2012. The primary features of this photograph include: a) the main hoist which is a rotary drum from which the crane cable is unwrapped for lowering a load (and wrapped for raising a load), b) the four hydraulic motors that are used to apply raising and lower torque on the main hoist, c) the cross-over relief valve "N" which keeps the high pressure side of the circuit from over pressurizing, and d) the counter balance valve which is used to hold the crane load in place in the absence of a command input from the pumps which supply flow to the motors. It should be noted that the hydraulic power unit (including the diesel engine and hydraulic pumps) is not shown in Figure 1. Other hydraulic components shown in Figure 1 are used to service the

Figure 1. A photograph of the crane hoist system before the hydraulic motors 1-4 were removed and inspected at Federated Crane on March 1, 2012

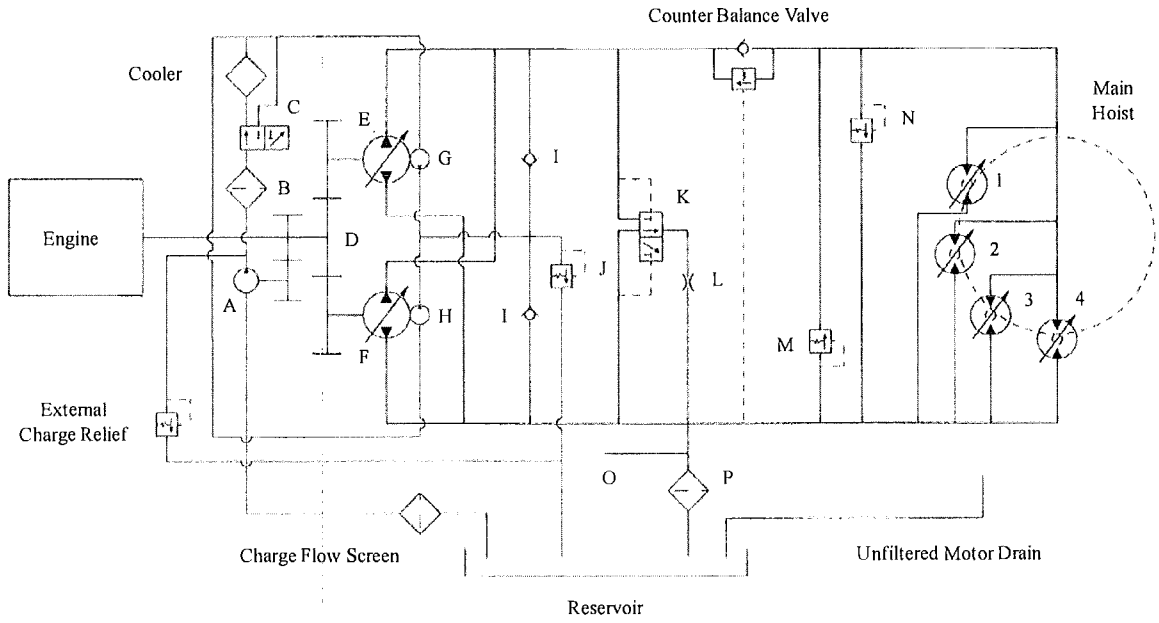
Figure 2. A schematic of the hydraulic circuit for the main hoist system

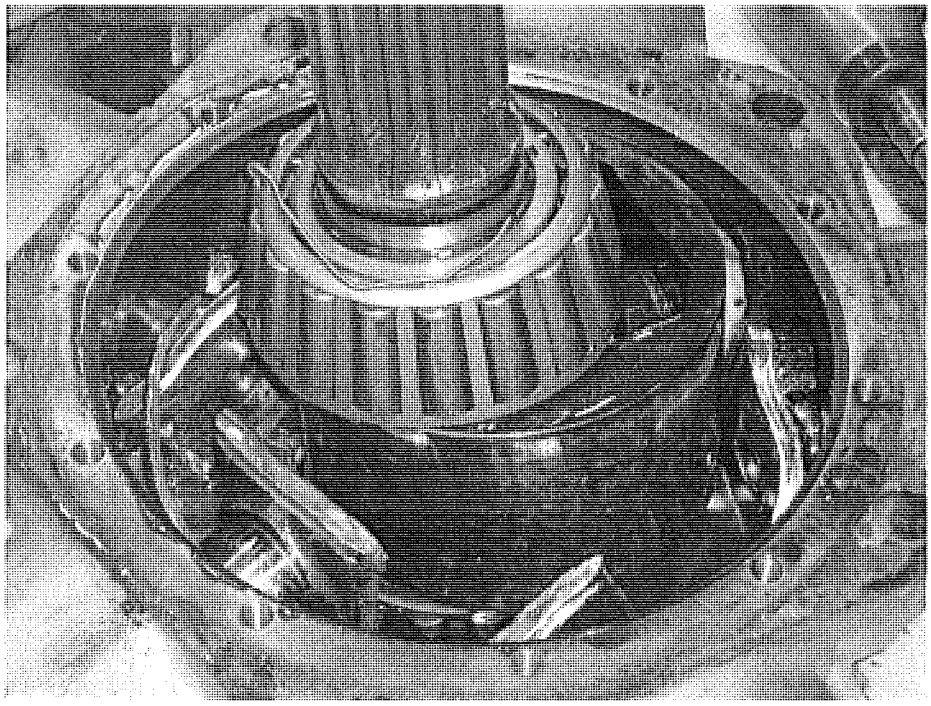
Figure 3. The typical finding of a motor failure in which metal parts were scattered randomly, conrod shoes were highly deformed, and motor pistons were either jammed or partially jammed within their bores.

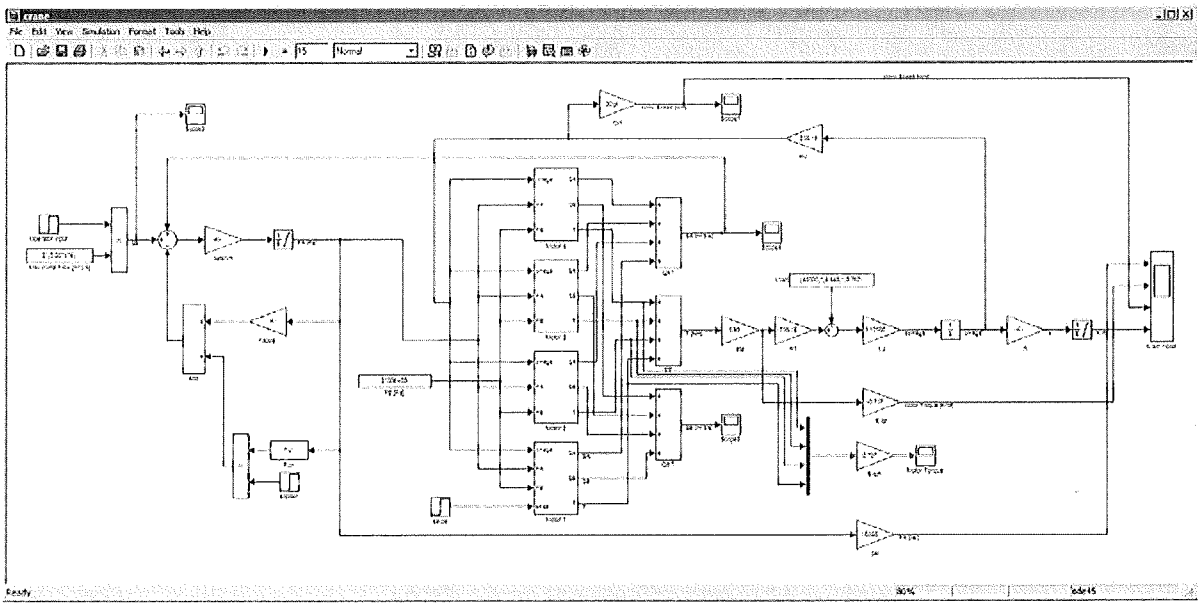
***Modeling.*** To examine the additional failure theory presented above; i.e., that a seized distributor in one of the Staffa motors caused the lost-load incident for the Linkbelt 1900 crane, a numerical simulation of the hoist system was conducted using mathematical modeling

Figure 4. The graphical user interface for the numerical model that was developed in Matlab/Simulink® for simulating the condition of a seized distributor in one of the motors

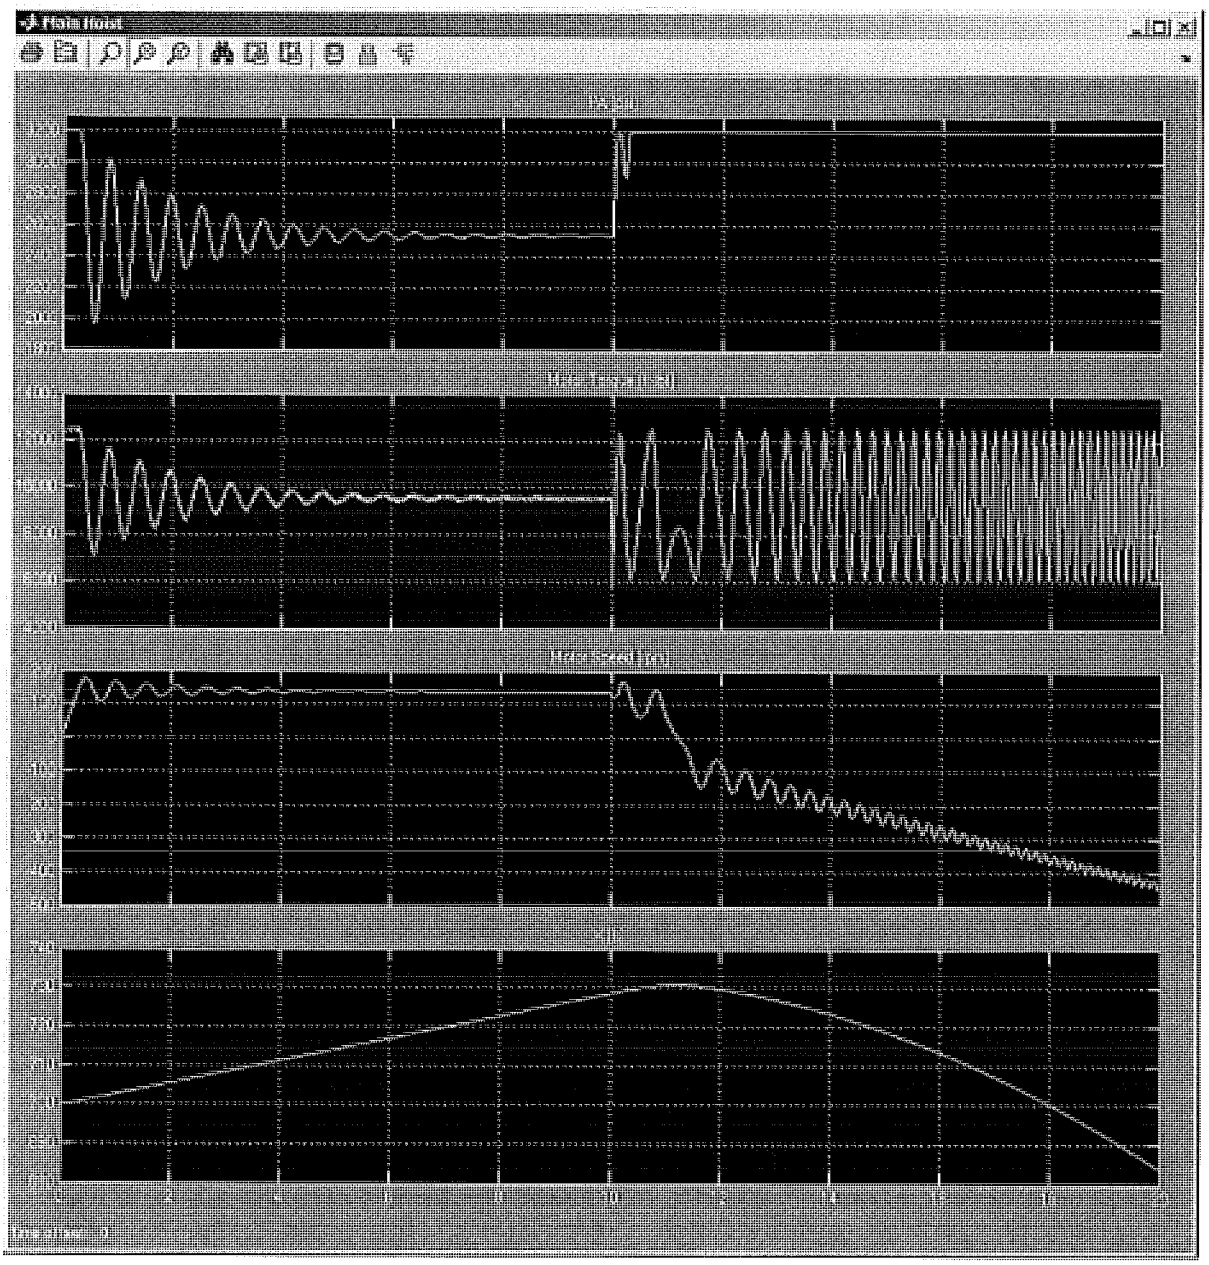
Figure 5. Simulation results for the lost-load incident of the Linkbelt 1900 crane, on February 16, 2012.

oscillatory effects of this torque on the total system are also shown in the second strip chart of Figure 5. In the end, this appears to be the most plausible explanation for the lost-load incident of February 16, 2012.

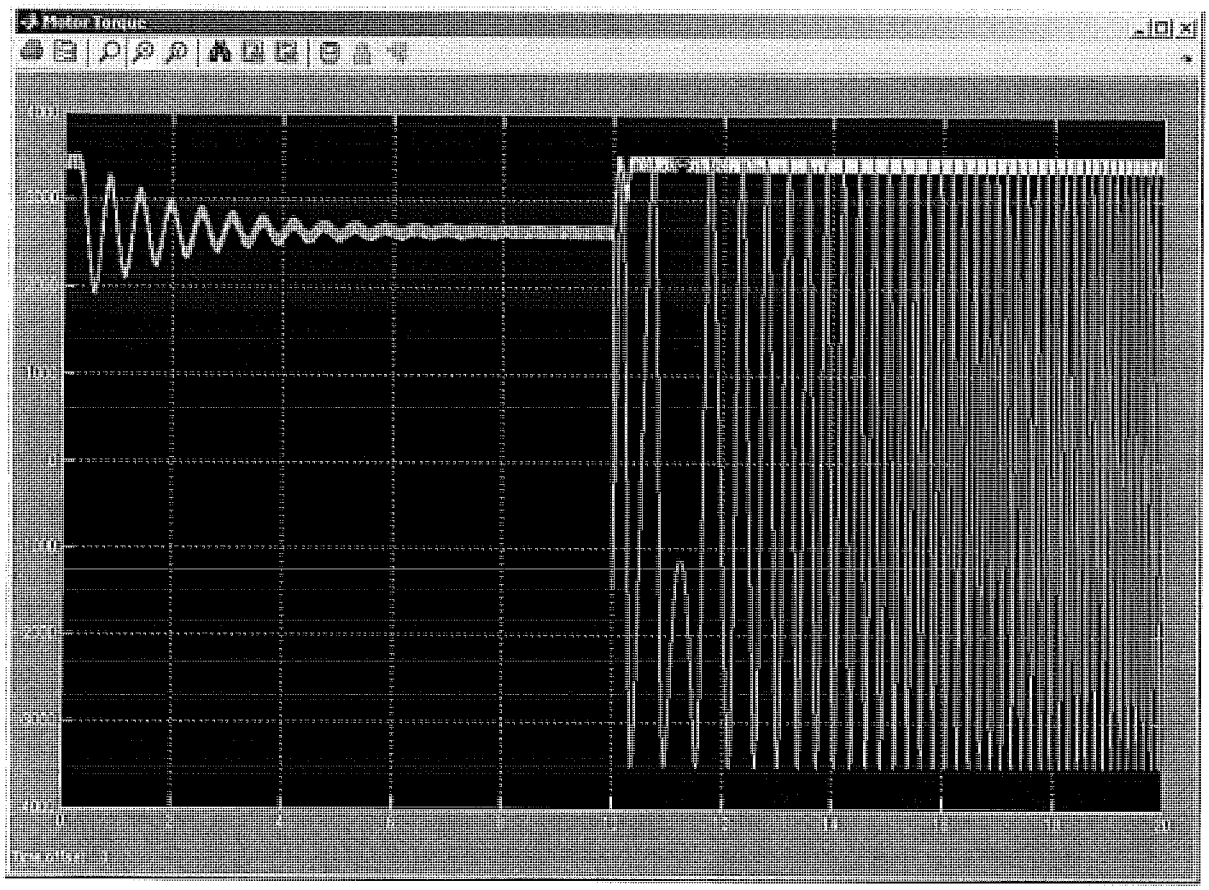
Figure 6. Instantaneous torque of all four motors being used to lift the load on the Linkbelt 1900 crane. The torque from the motor with a seized distributer is shown in red, and the average value of this torque is shown to oscillate about zero.

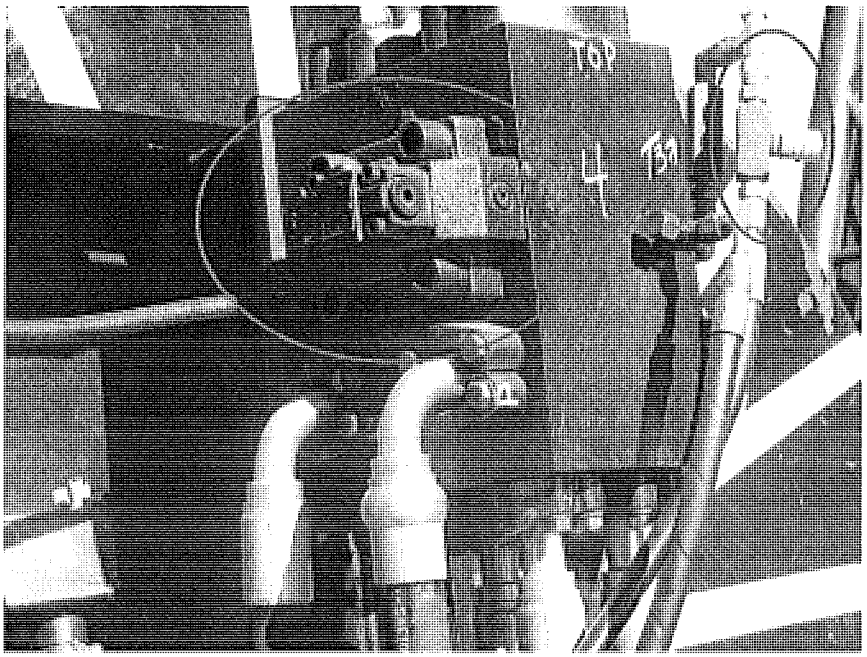
Figure 1
Load Relief Valve (left)
Adjustable Restriction (right)

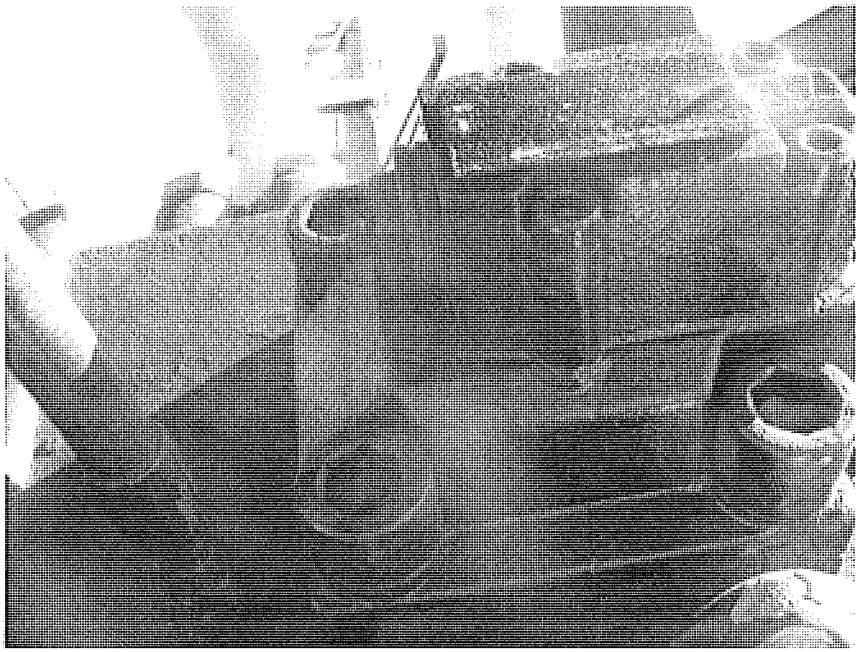
Figure 2
Load Relief Valve
Adjustment Screw

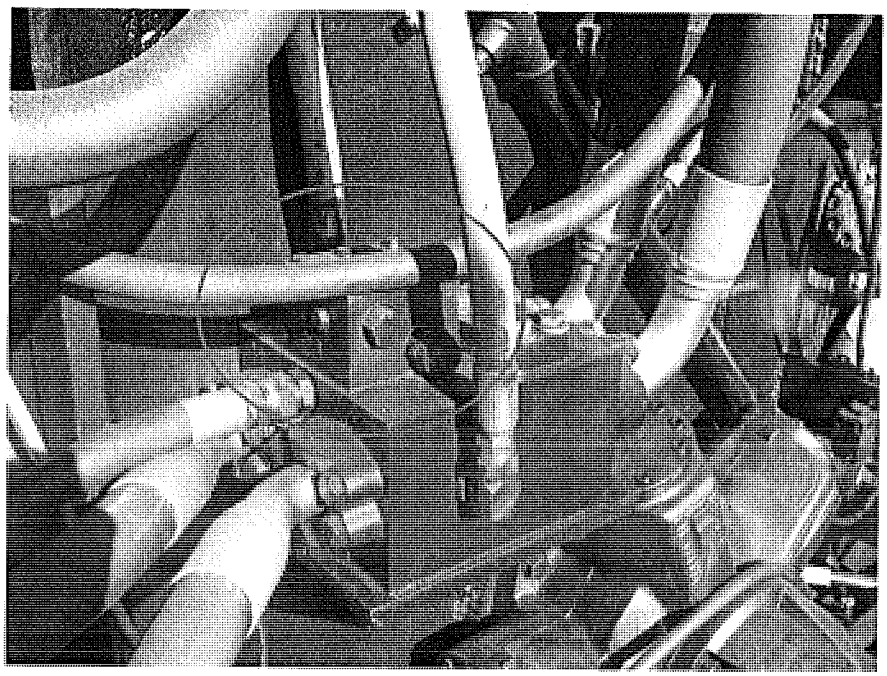
Figure 3
Cooling Shuttle Valve Assembly (typical)

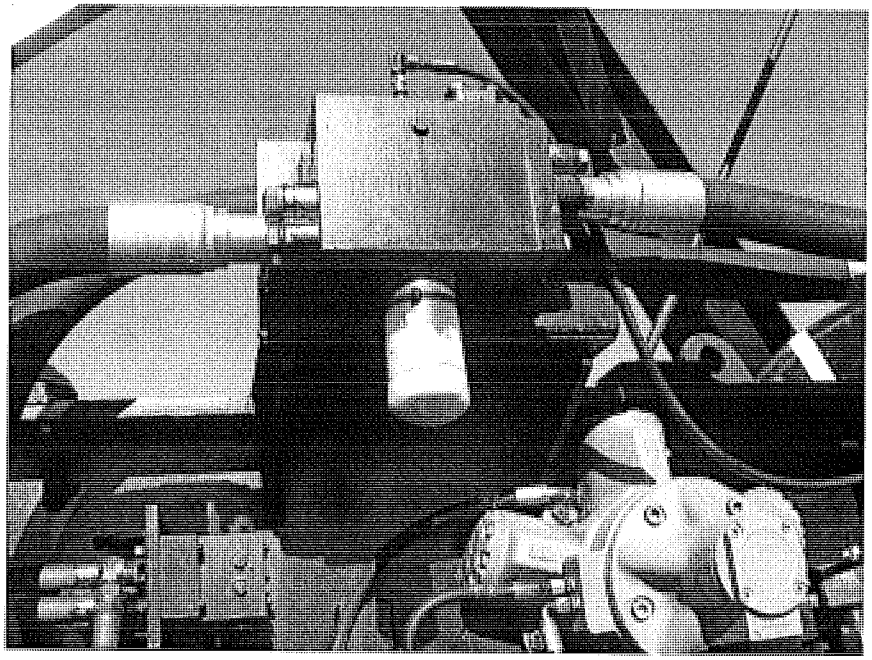
Figure 4
Load Holding Valve
(plastic cup in place)

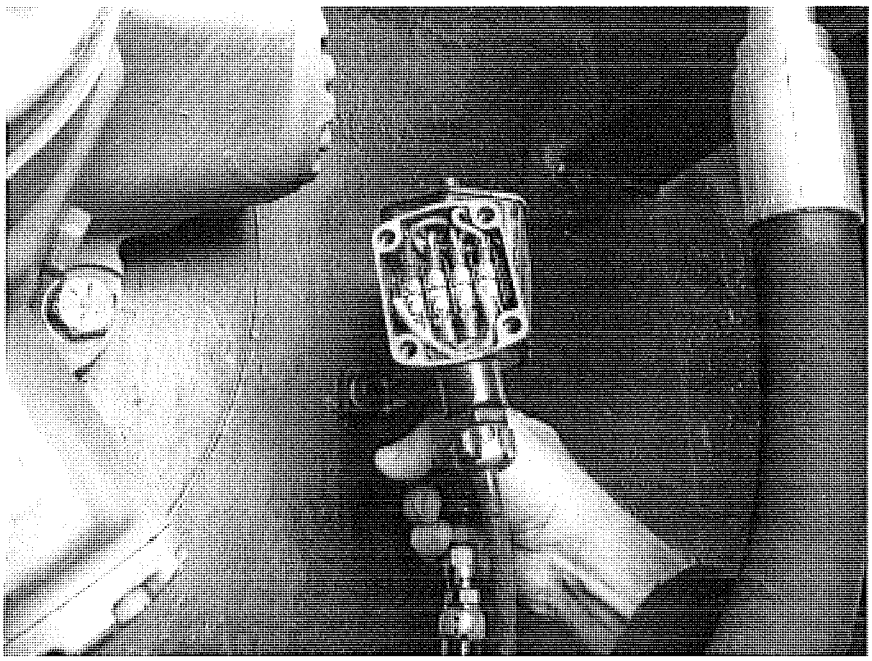
Figure 6
Barksdale Switch
Bypass Jumper Wire (green)

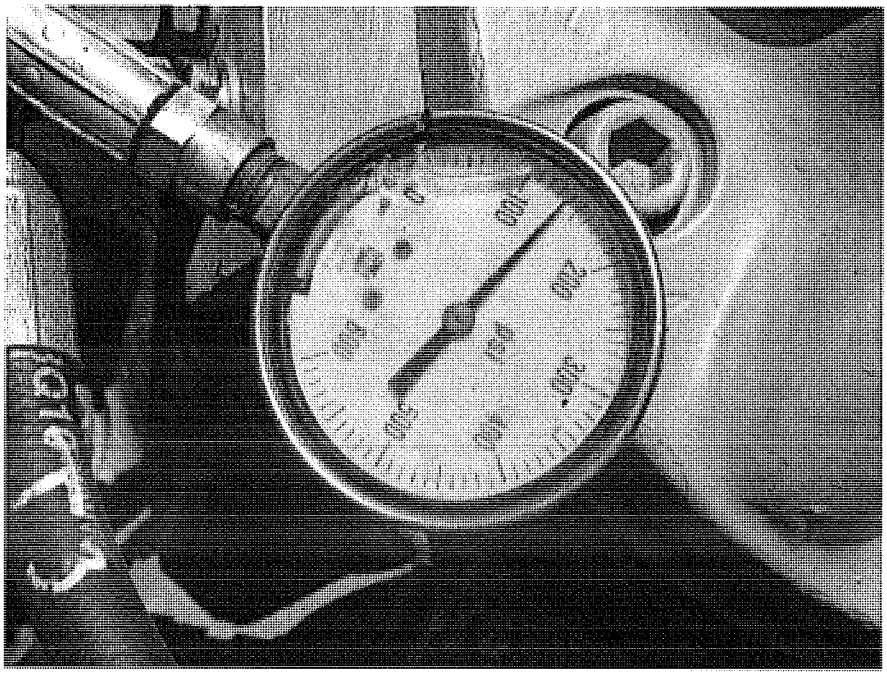
Shuttle Relief Valves set below the design value are likely to cause partial cavitation during sustained operation at higher motor speeds, with lower hook loads, contributing to overheating and the observed cumulative wear of the hydraulic motor distributors, which in turn has lead to the observed failure of one motor and near failure of the remaining two.

Figure 7
Shuttle Relief Valve Pressure

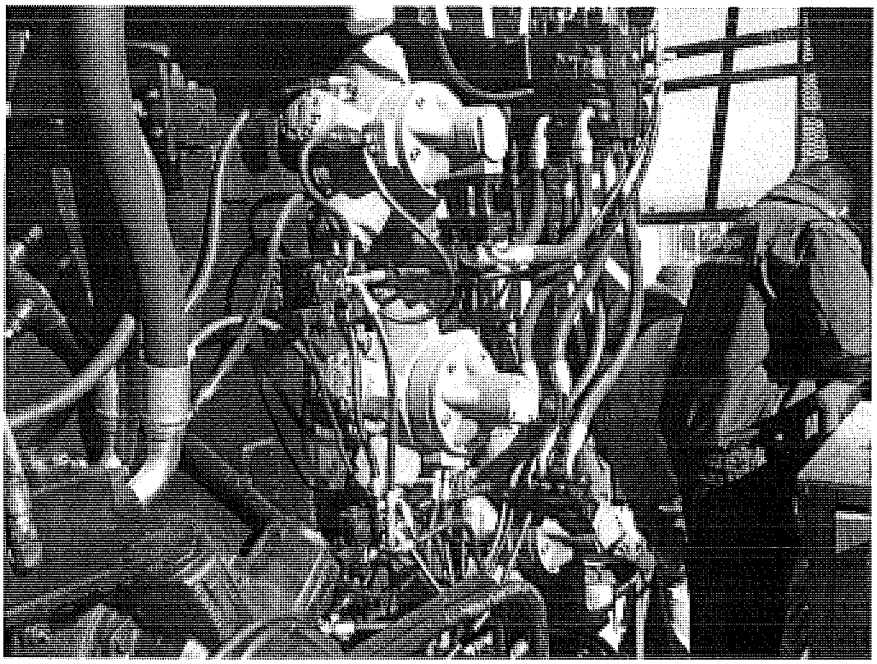
Figure 8
Staffa Radial Motors (3)
Boom Motor (1) at Bottom-left

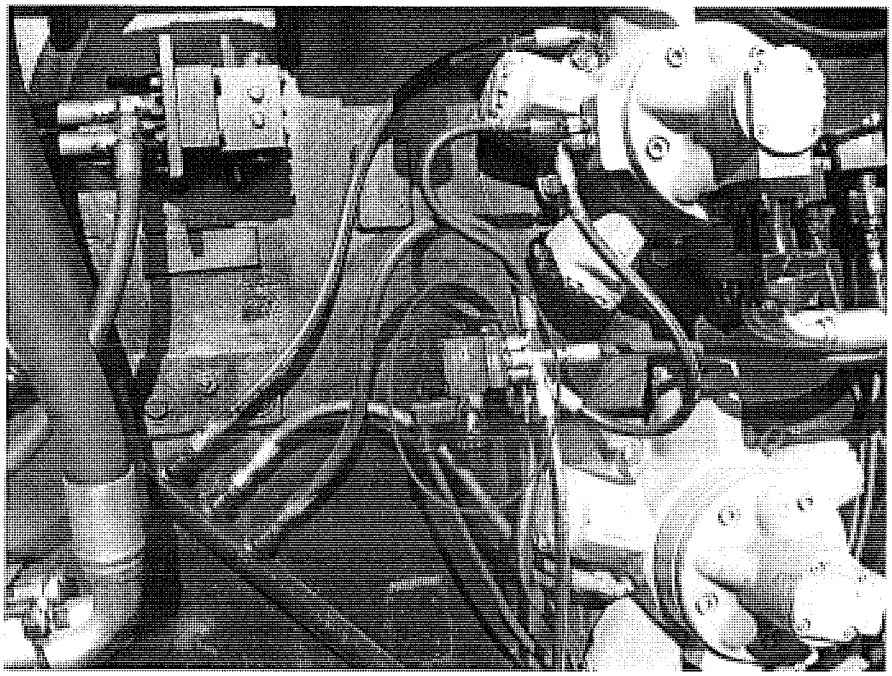
Figure 9
High Shift Valve
(typical)

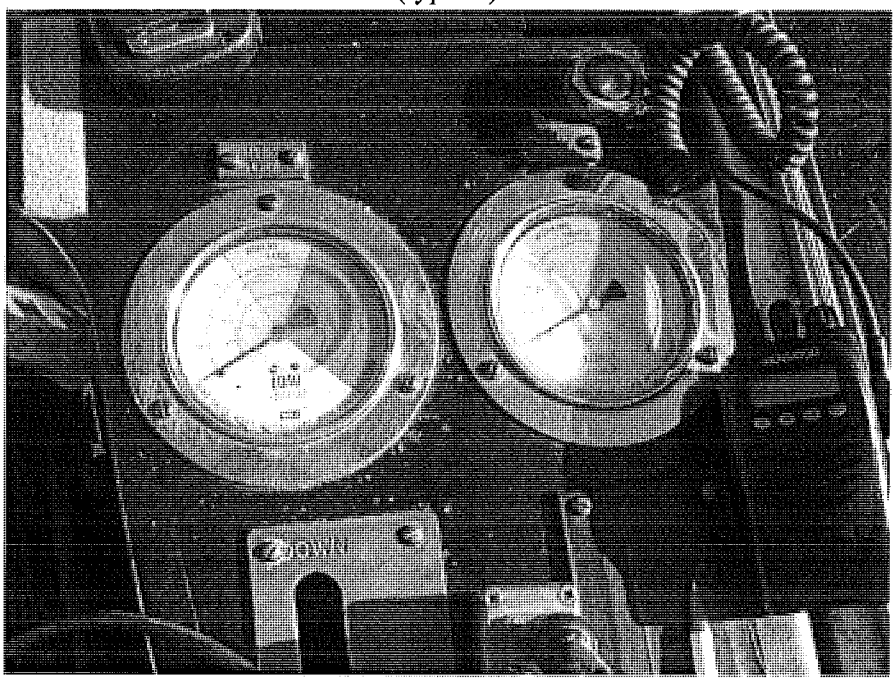
Figure 10
Low Charge Pressure Light
(apparently unmarked)

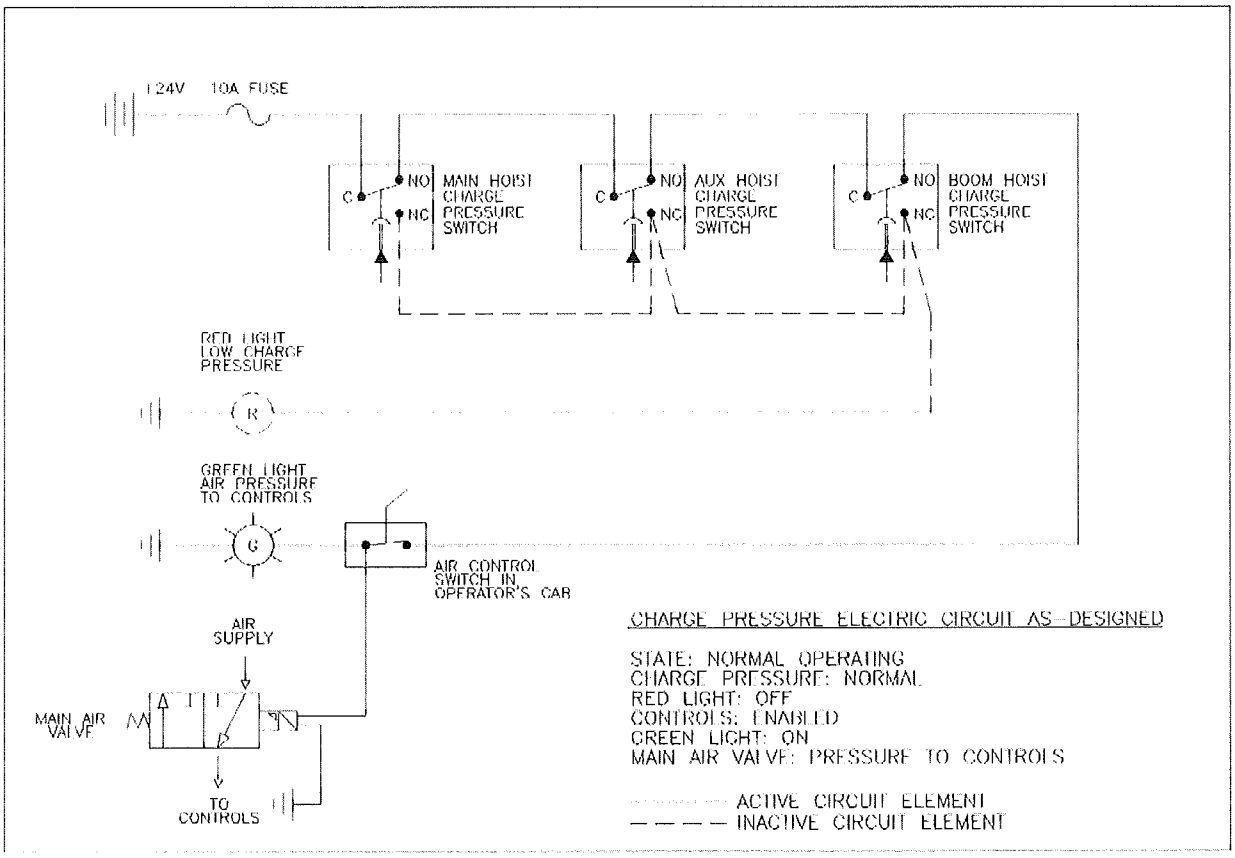
Figure 11
Charge Pressure Protection Circuit
As-designed
Normal Operation

With adequate charge pressure at each of the three Charge Pressure Switches, current passes from the source to the Air Control Switch on the operator's console, and on to the Main Air Valve, lighting the green light on the console. The operator's controls are enabled.

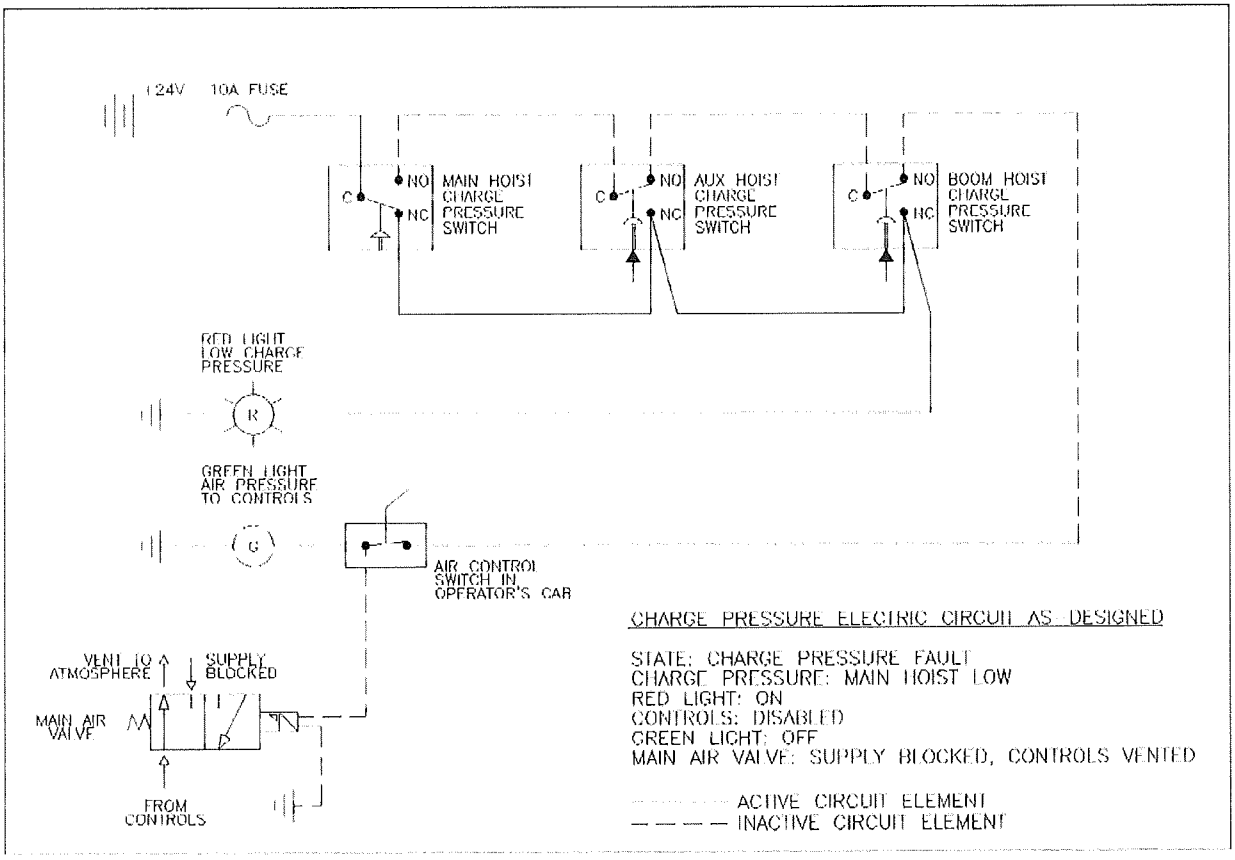
Figure 12
Charge Pressure Protection Circuit
As-designed
Low Charge Pressure

With low charge pressure at the main hoist Charge Pressure Switch, current passes from the source to the red light on the operator's console, and the circuit to the Main Air Valve and green light on the console is broken. Air within the operator's controls is vented to atmosphere, disabling the controls and setting the brakes.

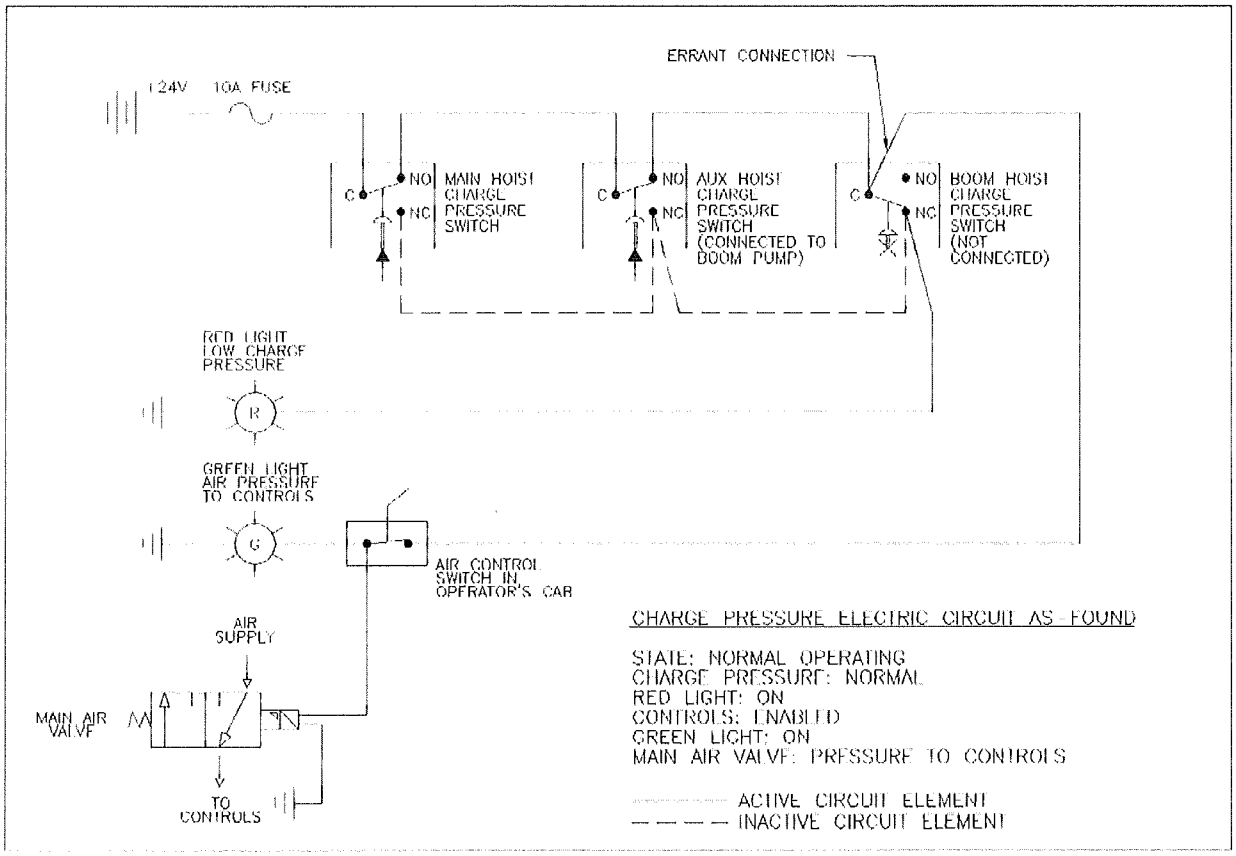
Figure 13
Charge Pressure Protection Circuit
As-Found
Normal Operation

With adequate charge pressure at each of the two working Charge Pressure Switches, and the original boom hoist Charge Pressure Switch hydraulically disconnected, current passes from the source to the Air Control Switch on the operator's console, and on to the Main Air Valve, lighting the green light on the console. The operator's controls are enabled. Current also passes through the boom hoist Charge Pressure Switch to the red Low Charge Pressure light on the operator's console.

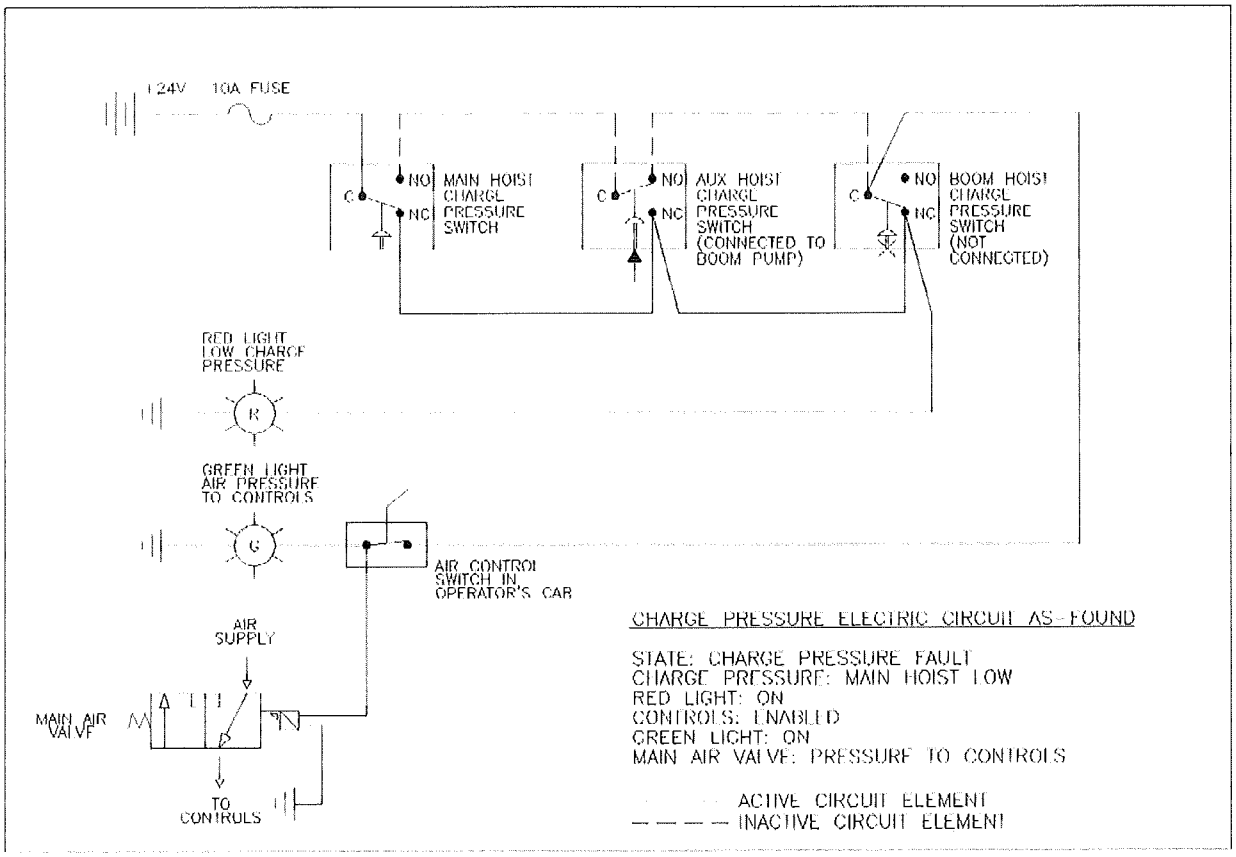
Figure 14
Charge Pressure Protection Circuit
As-Found
Low Charge Pressure

With low charge pressure at the main hoist Charge Pressure Switch, current passes from the source to the red light on the operator's console. Current is also back-fed through the boom hoist Charge Pressure Switch to the Air Control Switch on the operator's console and on to the Main Air Valve and green light on the operator's console. The operator's controls remain enabled, and the brakes remain under operator control rather than automatically setting.

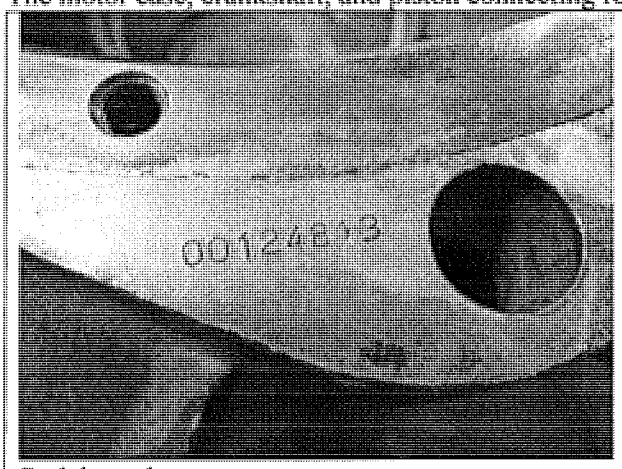
Serial number

**Serial #00124813**
This motor was identified as a new motor, meaning that it had operated for some time, but had never been previously repaired. It was also determined that this was the first motor to fail.
The Oldhams coupling in this motor was sheared and was able to spin upon the face of the crankshaft. The broken ends of the tang of the coupling remained inside the motor. The distributor valve housing was galled near the ports. The spool also had galling where it had contacted the valve housing. The o-rings in the C spacer housing were damaged. The inside surface of the connecting rod hold down rings had heavy contact with the connecting rod shoes.
The motor case, crankshaft, and piston connecting rod assemblies are all good condition.

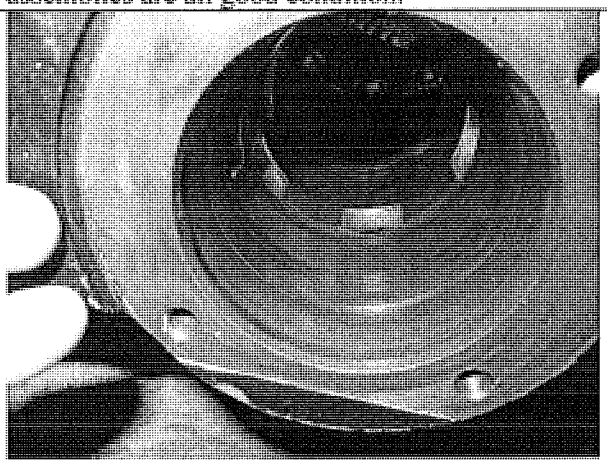
Distributor housing. Galling near ports.

Broken Oldhams coupling

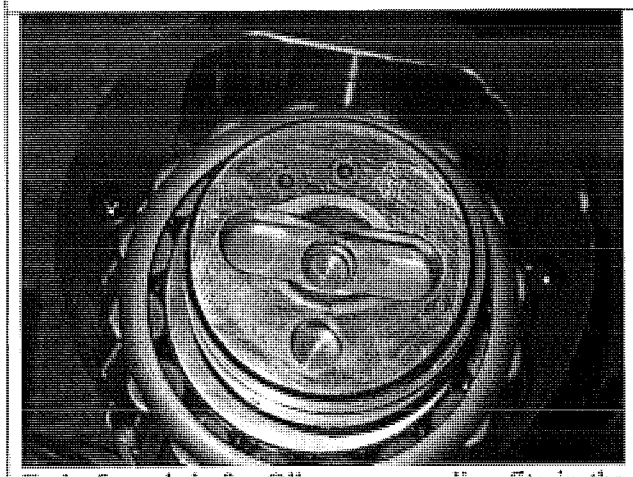
End of crankshaft. Olhamans coupling fits in the slot. The face is marked where the coupling contacted it while the crankshaft was turning.

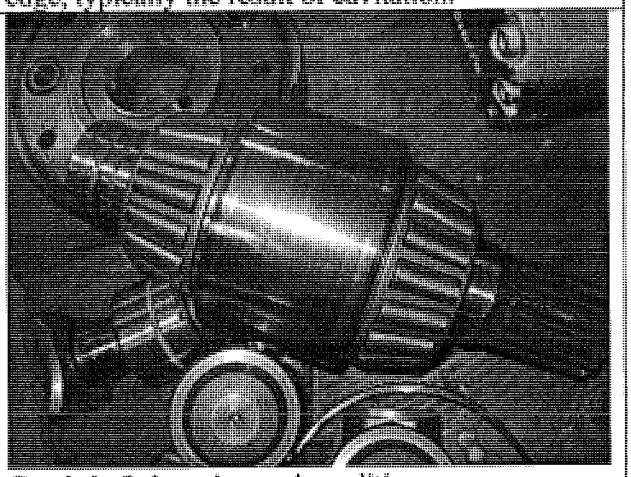
Crankshaft drum in good condition.

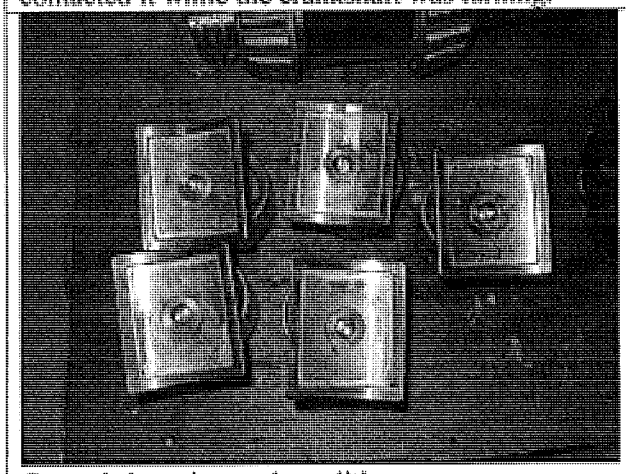
Conrod shoes in good condition.

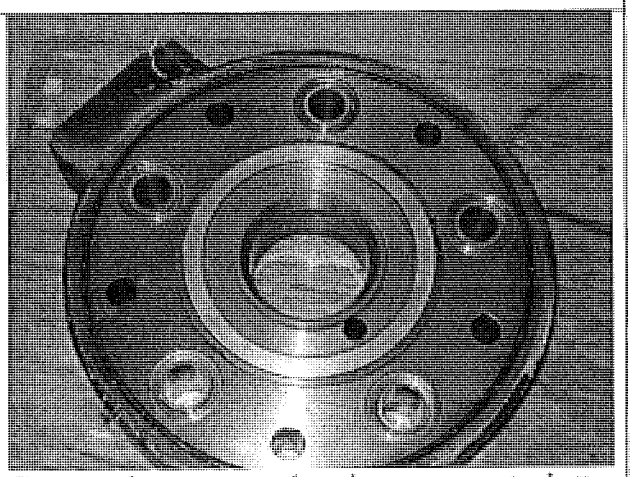
C-spacer has trepanned o-ring grooves to better retain the seals.

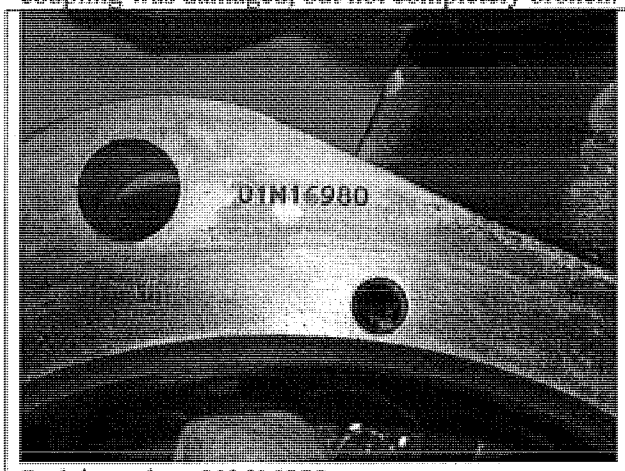
Serial number 01M16980

The galling of the distributor is likely the result of a lack of lubrication, which is most often caused by cavitation or over speeding of the spool. Displacement of the o-rings is known to be caused by cavitation. If the motor is starved of oil and there is no oil flowing out, the motor can spin without control. Starved of lubrication, the spool will seize in the bore and lock. In this case, the drive coupling was damaged, but not completely broken.

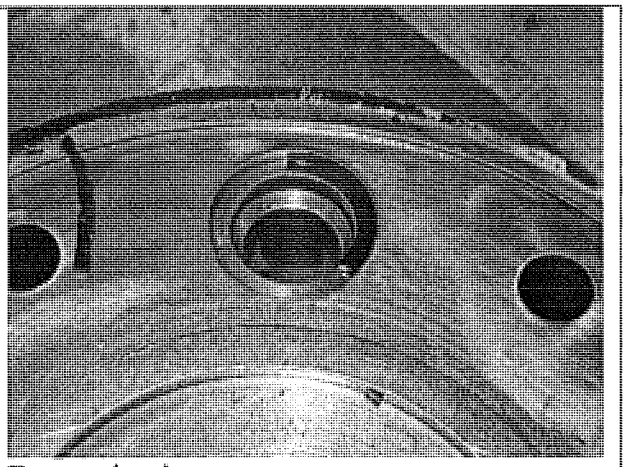
Damaged o-rings

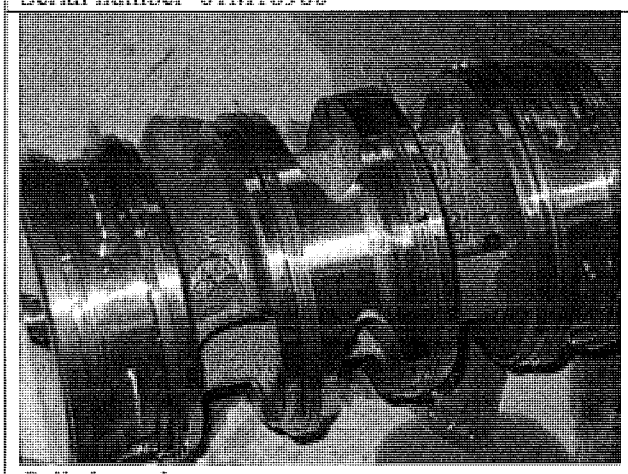
Galled spool.

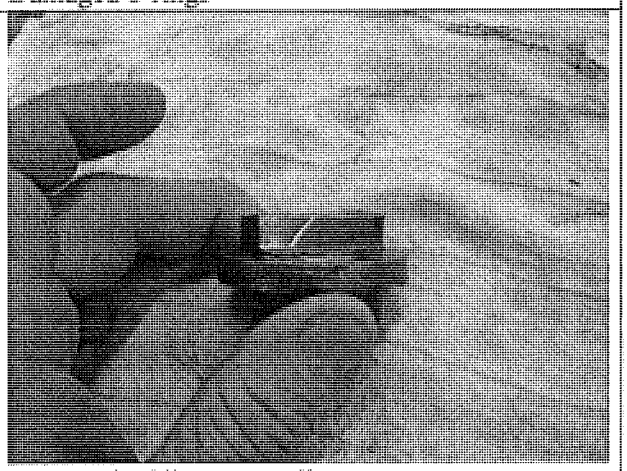
Damaged Oldhams coupling

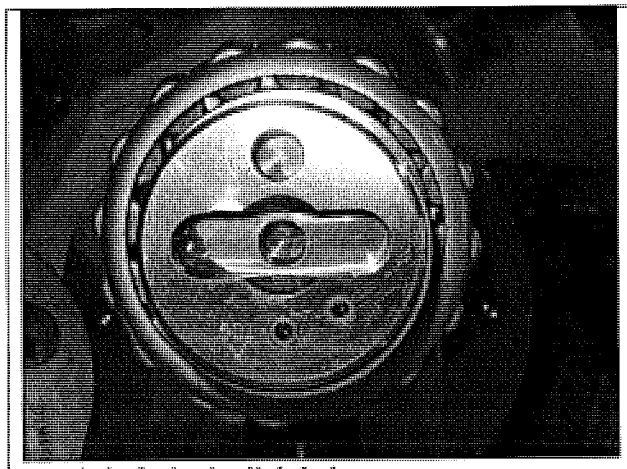
Crankshaft slot is slightly bent.

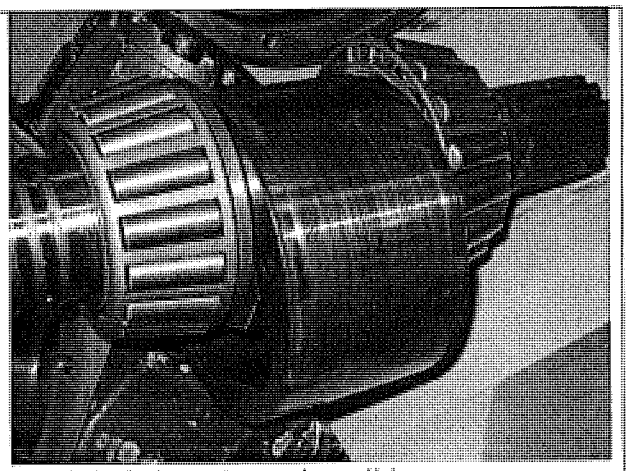
Crankshaft throw is good condition.

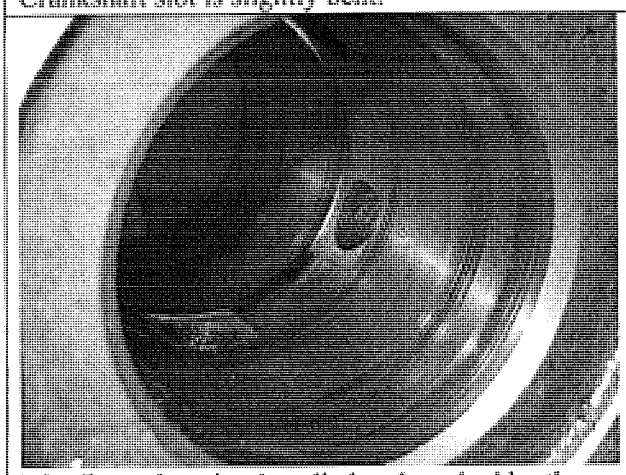
Distributor housing is galled and marked by the spool rings.

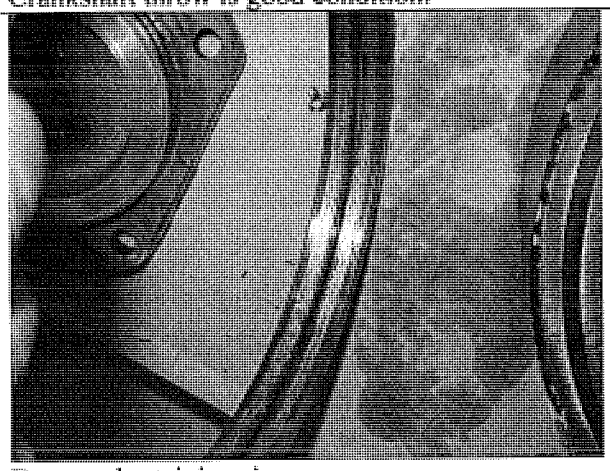
Damaged retaining rings.

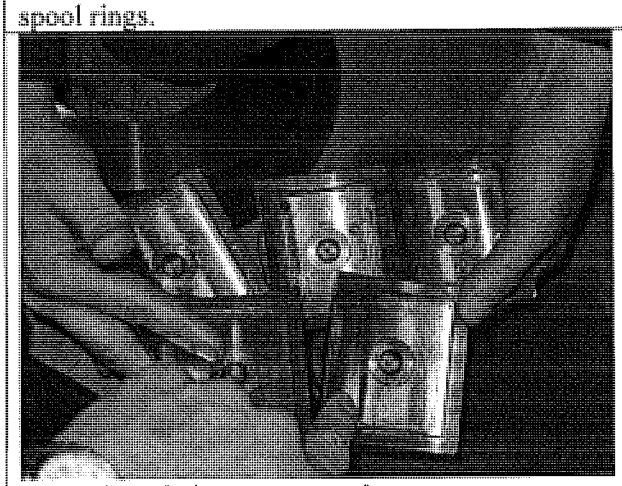
Conrods and pistons are good.

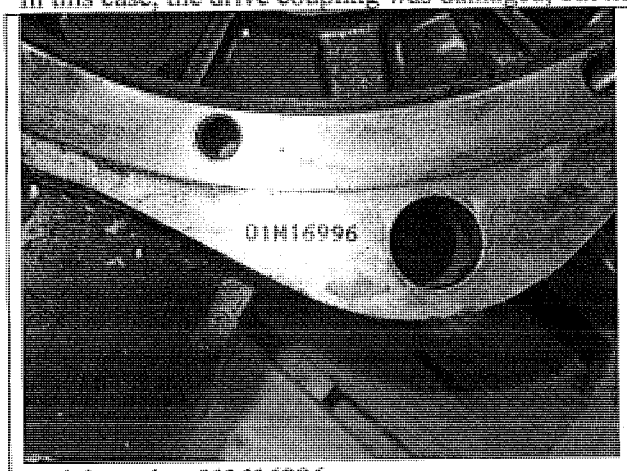
Serial number 01M16996

The galling of the distributor is likely the result of a lack of lubrication, which is often caused by cavitation or over speeding of the motor. If the motor is starved of oil and there is no oil flowing out, the motor can spin without control. Starved of lubrication, the spool will seize in the bore and lock. In this case, the drive coupling was damaged, but not completely broken.

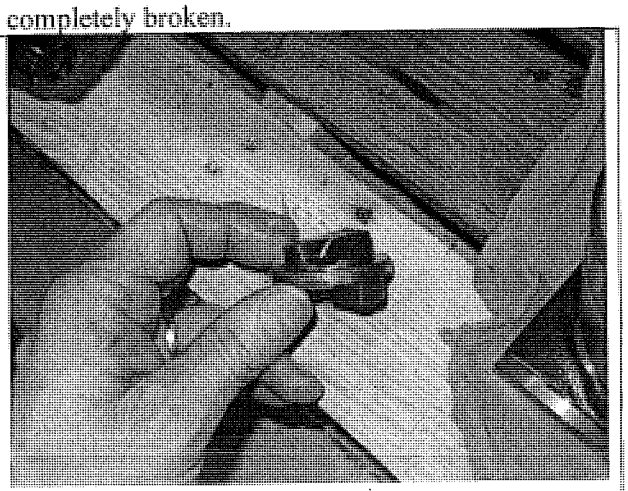
Oldhams coupling is deformed

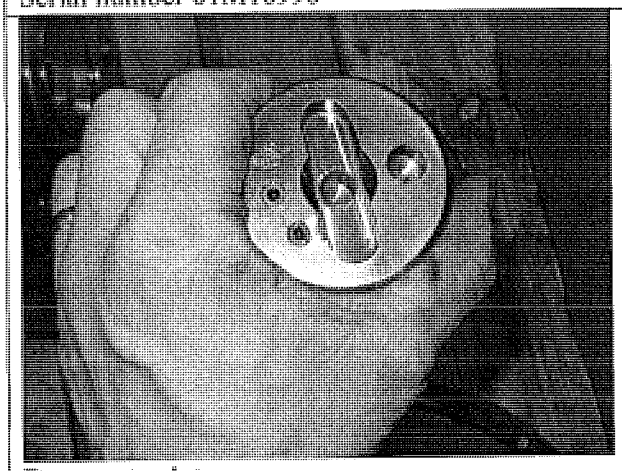
Damage to slot.

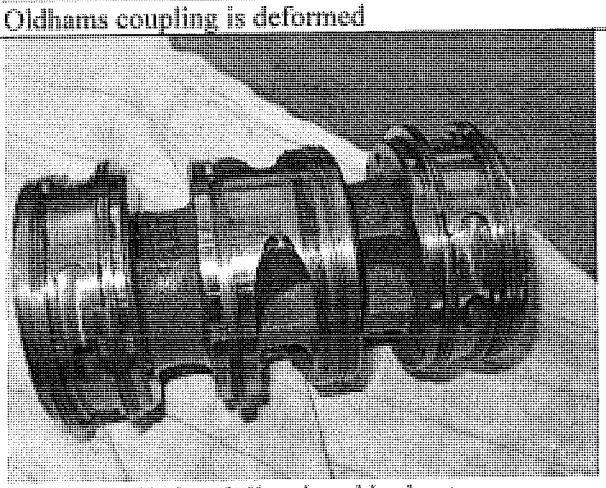
Spool is galled and discolored by heat

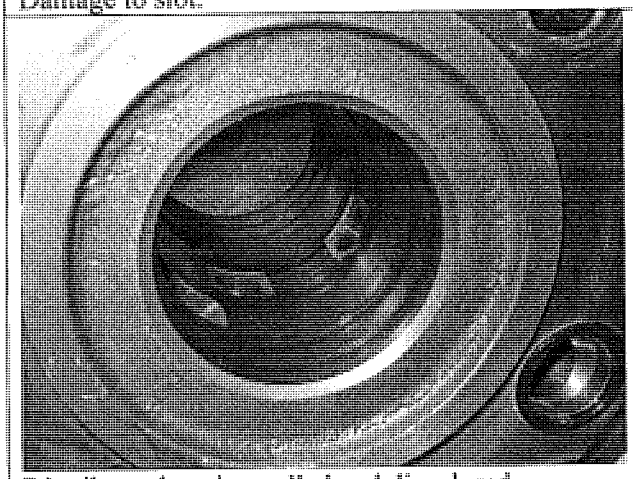
Distributor housing galled and discolored.
