List of specific record(s):
Please provide any and all reports generated by Haag Engineering related to the February 16th, 2012 crane accident on the World Trade Center Tower 4 Project, involving the TG1900 Tower Crane SN 76G9-1206C CD 3705

World Trade Center 4500063211
4 World Trade Center
New York, NY
Client File: 4500063211
Haag File: 0212001176-250

The Port Authority of NY and NJ
Port Authority Safety Board
225 Park Avenue South 15th Floor
New York, NY 10003

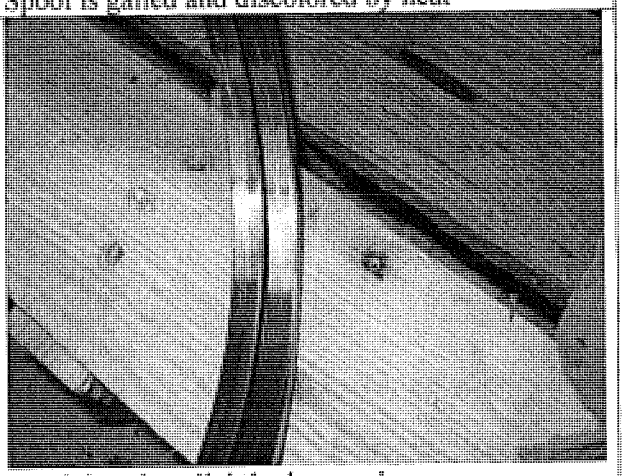
Retaining rings lightly damaged.

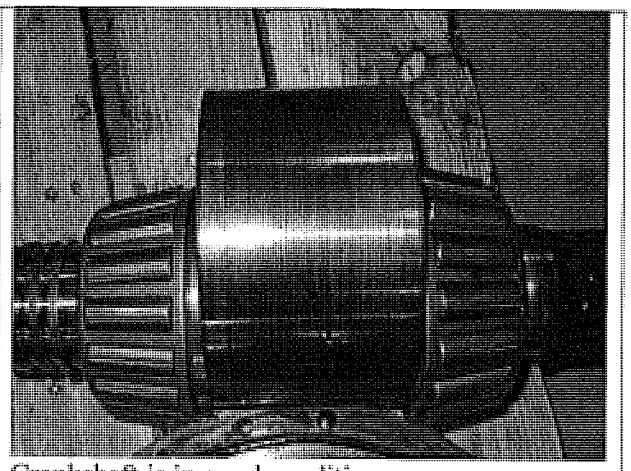
Crankshaft is in good condition

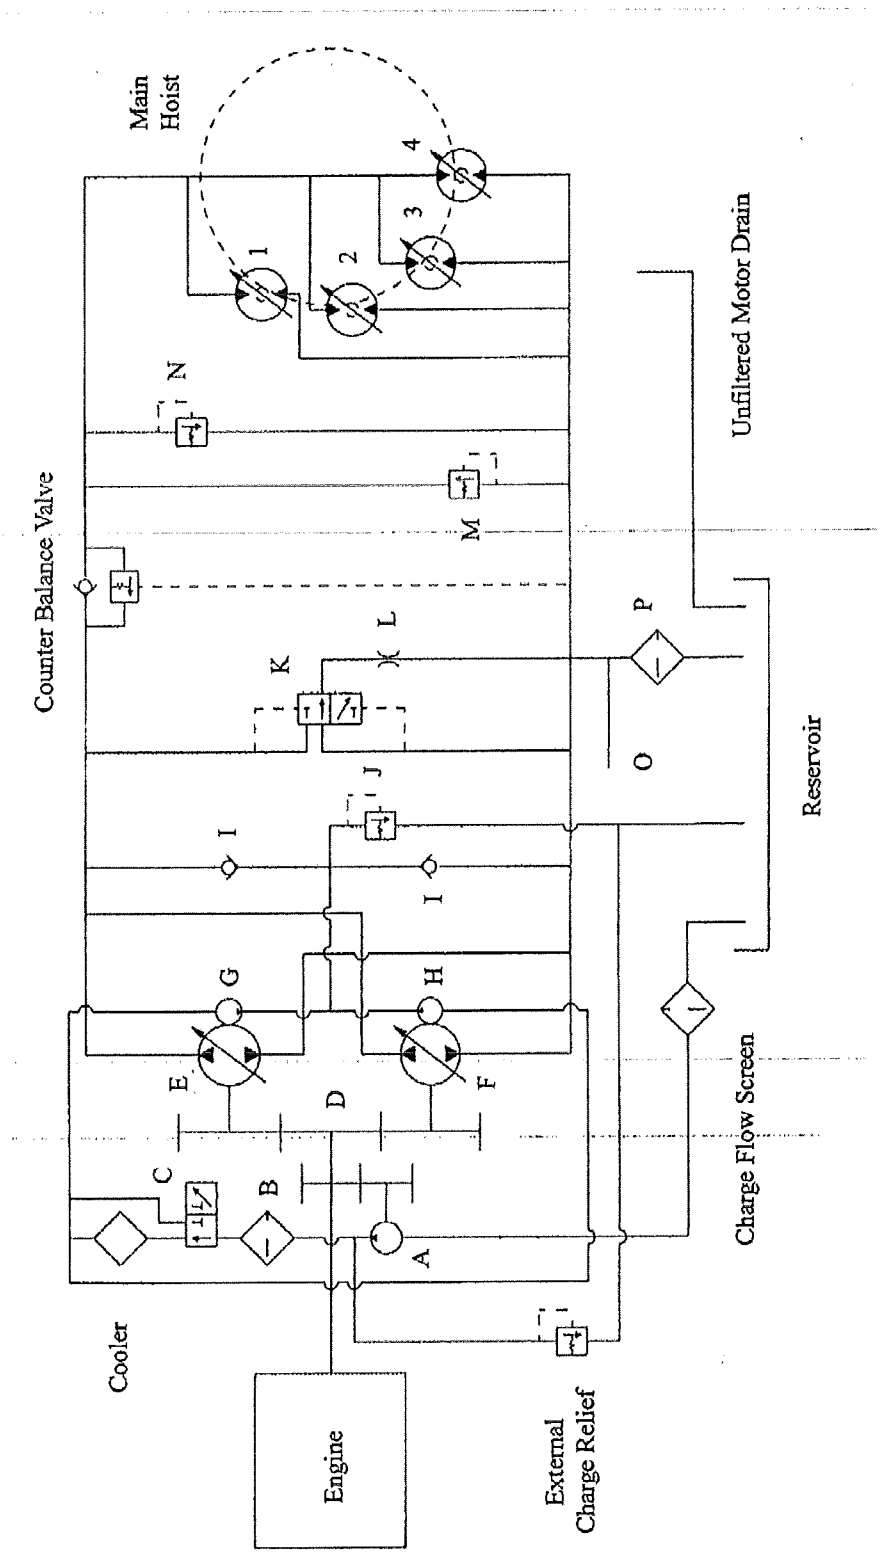
Figure 1. Schematic of the main hoist hydraulic circuit

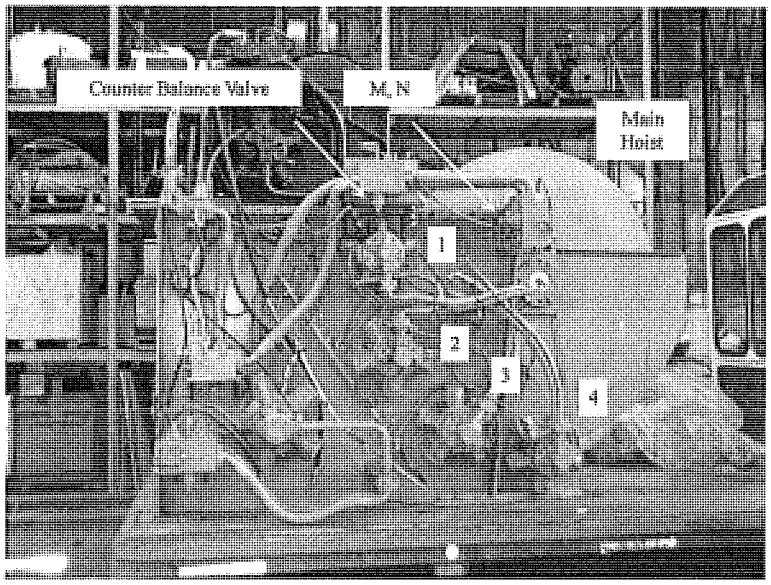
Figure 2. Photograph of the winch pack with several components in Figure 1 labeled

1. The hydraulic motor labeled 4 in Figure 1 and 2 was disassembled first. There was an obvious interest in disassembling this motor first because it the case had a large hole in it, from which a connecting rod had been thrown out of the machine during failure, along with another large piece of metal that appeared to belong to one of the hydrostatic bearings. The following things were observed during the disassembly process:
   a. Two jars of oil were extracted from the motor case before the motor was removed from the winch pack. These have yet to be analyzed.
   b. Seals and o-rings for the motor appeared to be in good shape, with no unusual signs of extrusion or other deformation.
   c. There were many metal parts scattered throughout the motor case ranging from long strips of material extending up to 30 cm in length to observable metal shavings less than

one millimeter in size. Many small pieces of metal were found of the approximate size of a penny. Most of these metal parts appear to have come from the mangled hydrostatic thrust bearings which had been destroyed due to an apparent over-speed phenomenon.

d. The machine was designed with 5 pistons. The piston labeled number 1 was the only piston to have lost its connecting rod. In fact, the connecting rod was found on the job site, indicating that this was the object that had most likely created the hole in the motor case. By disconnecting the connecting rod from the piston, a 5 mm lubrication passage from the pressurized side of the piston was opened up to the motor case. With a 5 mm hole like this, it is unlikely that the system could have held system pressure.

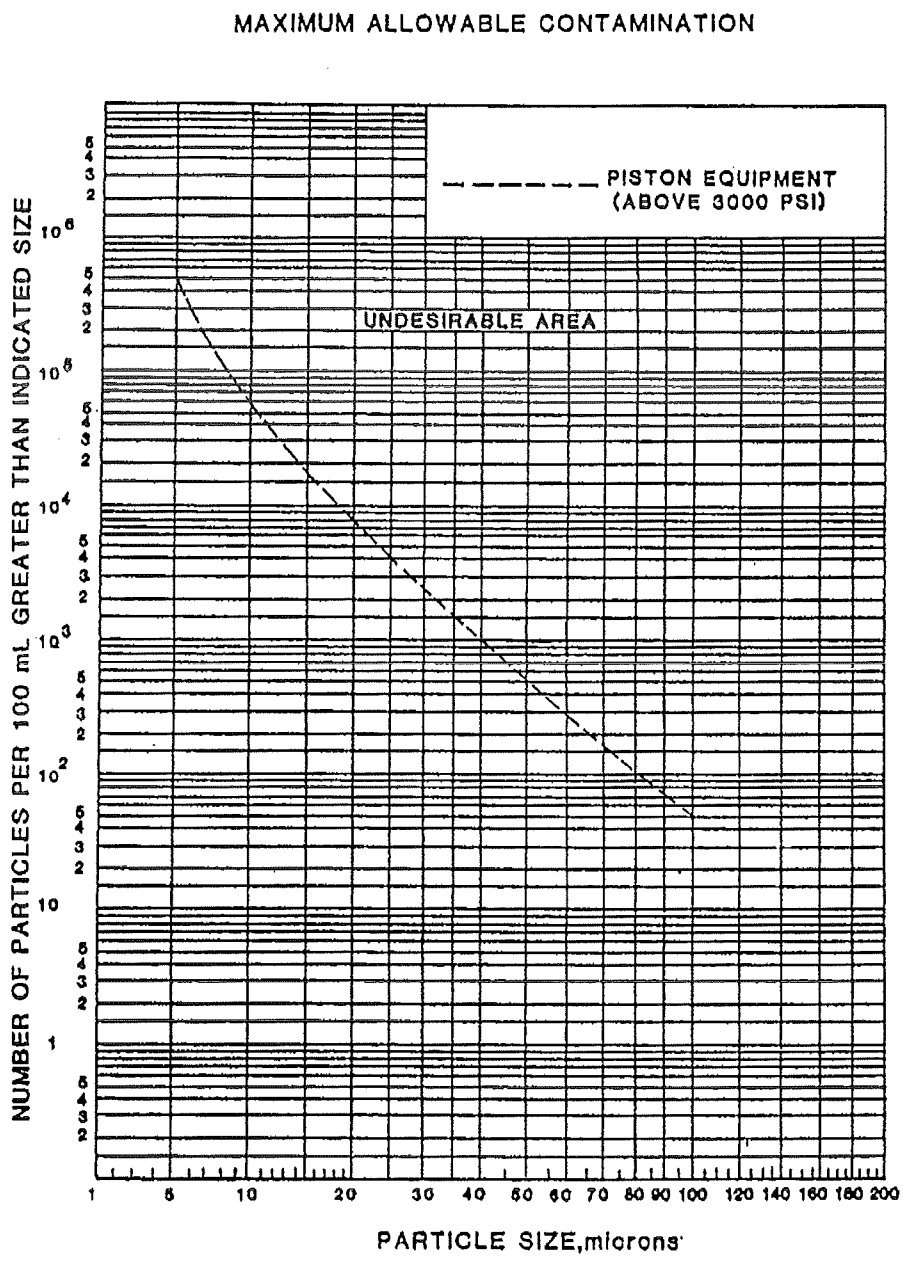
Fig. 5-35
Maximum Allowable Contamination Level

Under the heading, "Allowable Contamination Level" on page 5-44 of the manufacturer operator's and maintenance manual states, "Figure 5-35 shows the maximum allowable contamination level for this model crane. Any count above that level means that the hydraulic oil must be replaced..." (Refer to **Attachment E** for Figure 5-35.)

Figure 5-35 shows the maximum allowable contamination level for this model crane. Any count above that level means that the hydraulic oil must be replaced as described earlier in this section of the manual, or filtered using a filter buggy.

The oil must be filtered until the contaminate level is below that shown in Fig. 5-35.

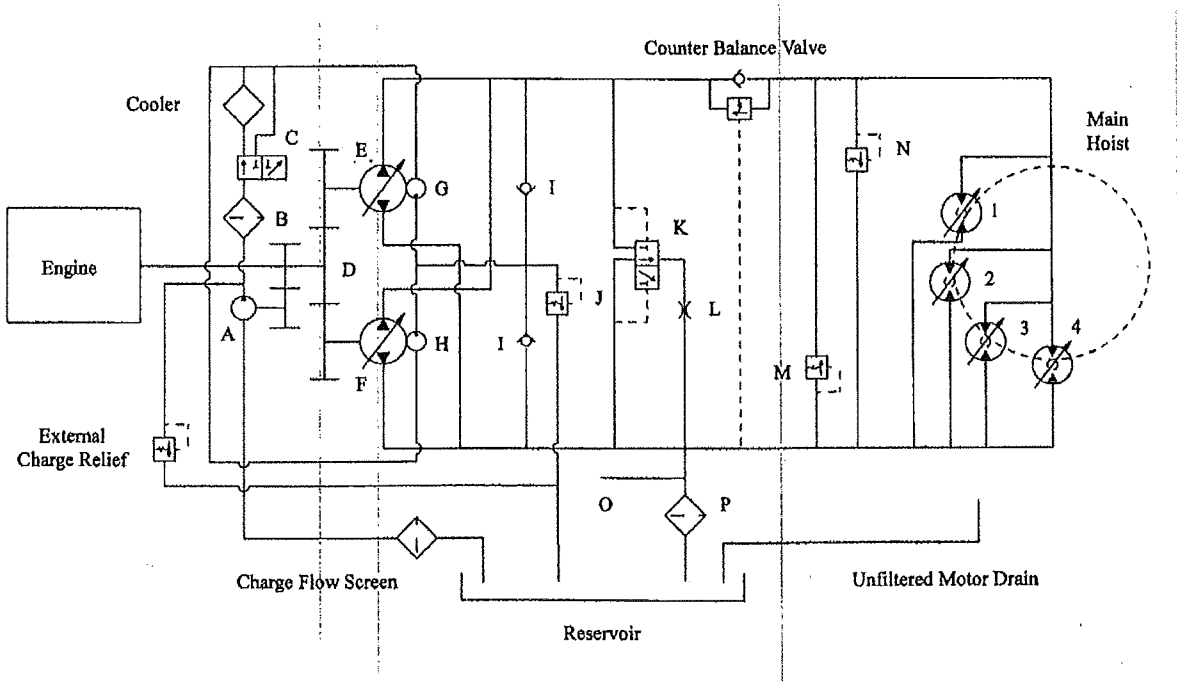
undergoes the seizing of a distributor; thus, effectively disabling the motor from the lift circuit and reducing the load capacity of the crane. This hypothesis is supported by the fact that the coupling key between the motor shaft and the distributor was broken on all four motors of the crane that failed, and that a similar accident in 2011 discovered a broken coupling key in one of the motors used in that crane. Furthermore, a mathematical model of the crane lifting circuit has been built using Matlab / Simulink ® and this model reveals that a seized distributor in one motor would have been sufficient to drop the payload as was experienced during the actual accident. Other failure hypotheses have been tested in the numerical model as well, but none of these have shown probable cause for the accident. Therefore, the hypothesis of a seized distributor being the initial cause of the accident remains in the forefront of this investigation.

Figure 1. Crane hoist system, showing four motors for lifting the payload

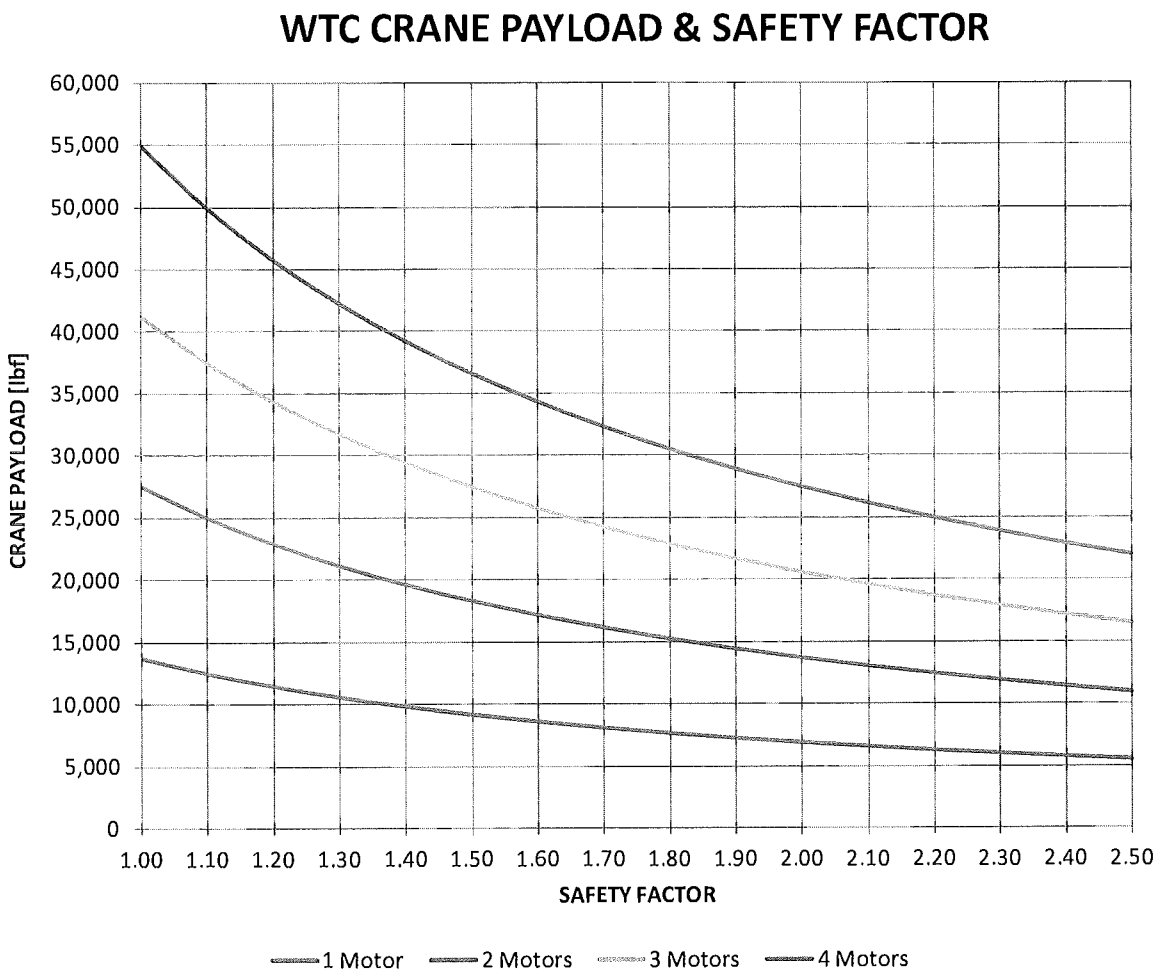
Using these parameters, the graph in Figure 2 was produced from Equation (3) to describe the recommended payload for the crane versus a desired safety factor for the lift. Note: a safety factor of 1.00 provides no margin for error. Usually, a safety factor between 1.00 and 2.00 is used for a safe design practice. In Figure 2, the graph is plotted for the number of motors that are active. The purple line represents a working condition where all four motors are active, the green line represents a condition where only three motors are active, the red line represents a condition where only two motors are active, etc. As Figure 2 shows, the recommended load carrying capacity for the crane decreases as the desired safety factor increases for all working conditions.

Figure 2. Payload capacity versus factor of safety and number of operating motors

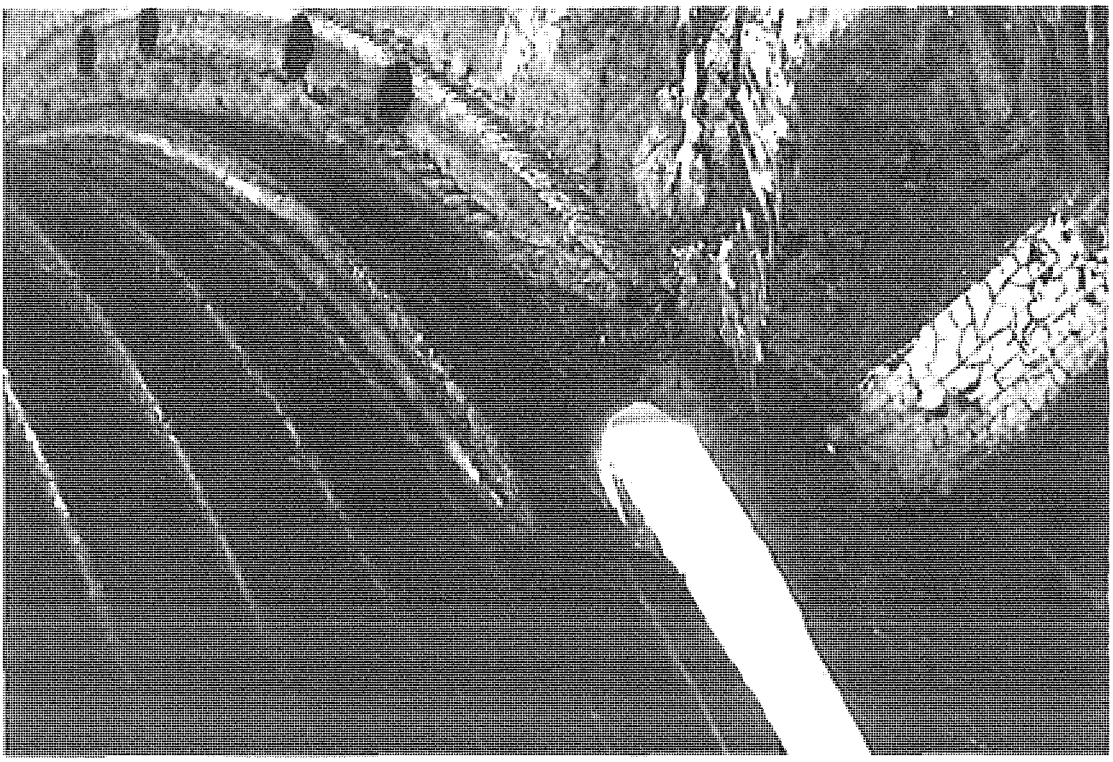
PHOTOGRAPH #1
INTERIOR VIEW OF DRUM POCKET

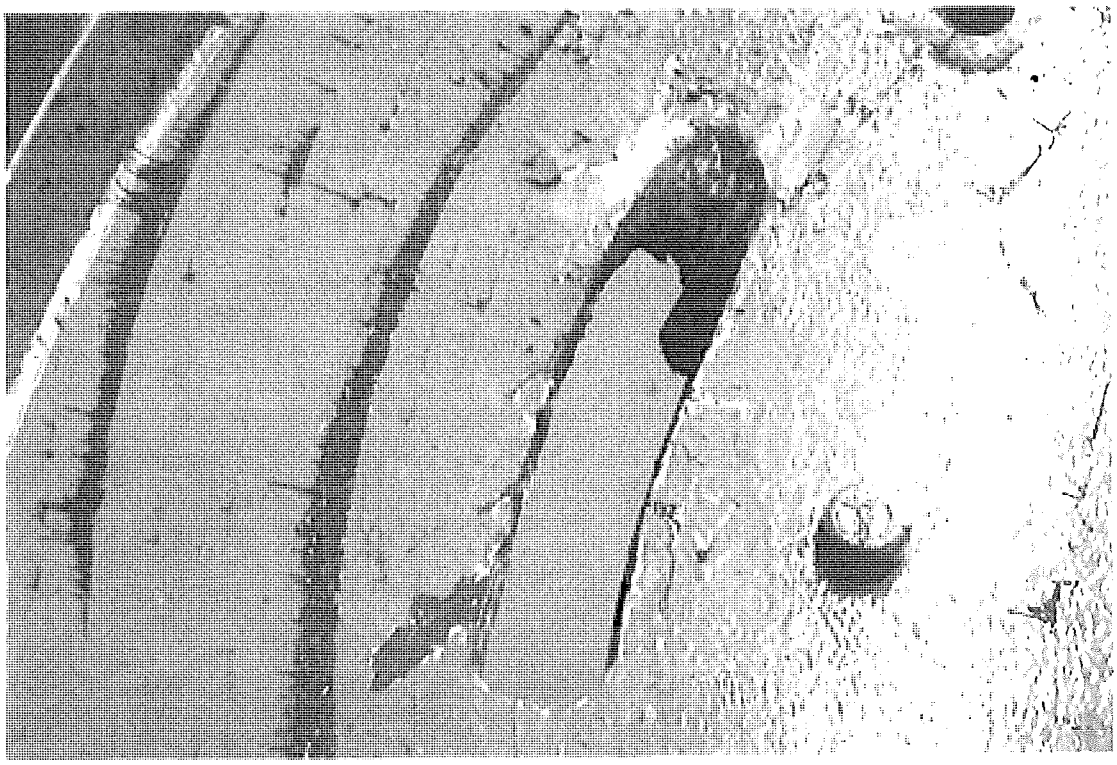
During the inspection of the drive drum at a second warehouse measurements were taken of the drum and photographs taken of the shearing location of the wire rope at the connection point on the drum (Photographs #1 & #2). Photograph #1 depicts the interior side of the drum flange where the wire rope was sheared during impact. The leading edge of the opening into the flange through which the wire rope passes for connection to the outer side of the flange is sharp and has been bent backwards from the high impact of the wire rope during shearing. Photograph #2 shows the exterior opening in the flange through which the wire rope passes for connection to the exterior surface of the flange. The clamps compressing the wire rope onto the outside of the flange of the drum were removed (Photograph #3) and the short 2' length of wire rope remaining on the drum was removed for inspection (Photographs #4 & #5). Photograph #4 shows the tail end of the wire rope that was inserted into the clamps, while photograph #5 depicts the failure end of the wire rope section still attached to the drum.

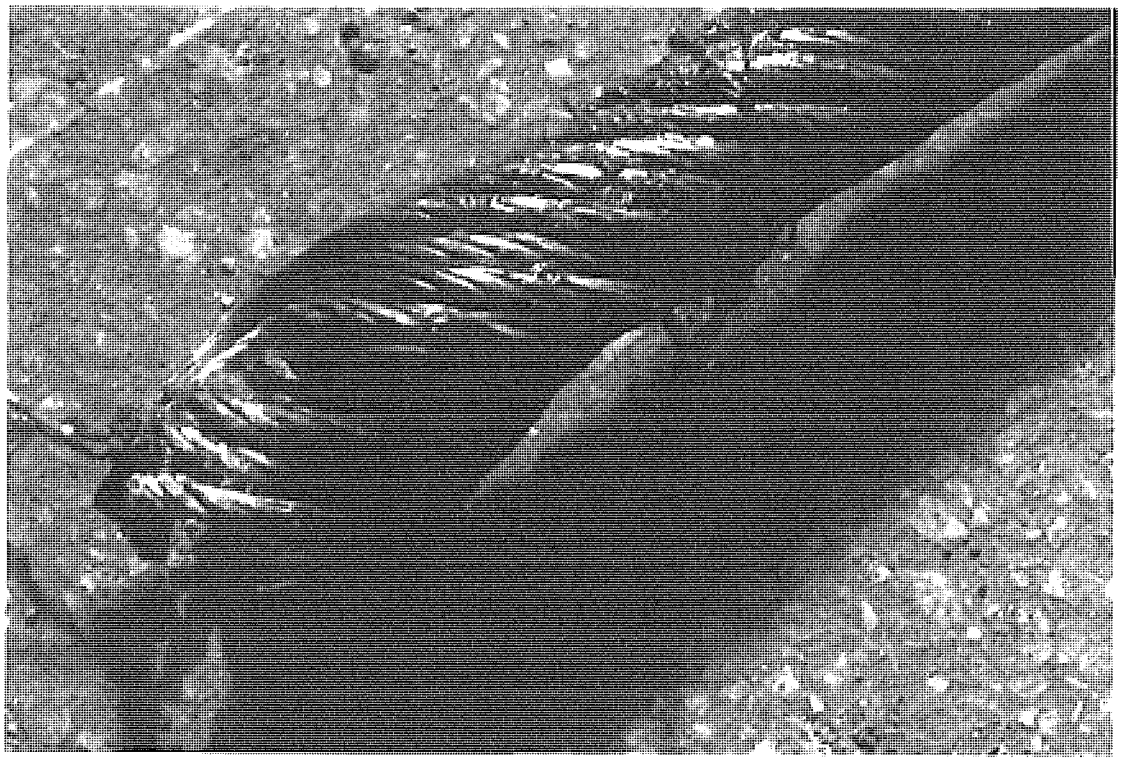
PHOTOGRAPH #3
WIRE ROPE CLAMPS BEING REMOVED FROM DRUM

The length of wire rope containing the end of the failure off of the drive drum is 10'-5" long with the failure end shown in Photograph #10. This failure end of the wire rope reveals that all 16 outer strands broke at the first set of clamps at the connection point on the drum (Photograph #3). The IWRC, or core of this wire rope, broke away from this location at approximately the very end of the wire rope positioned within the drum clamps (Photograph #4).

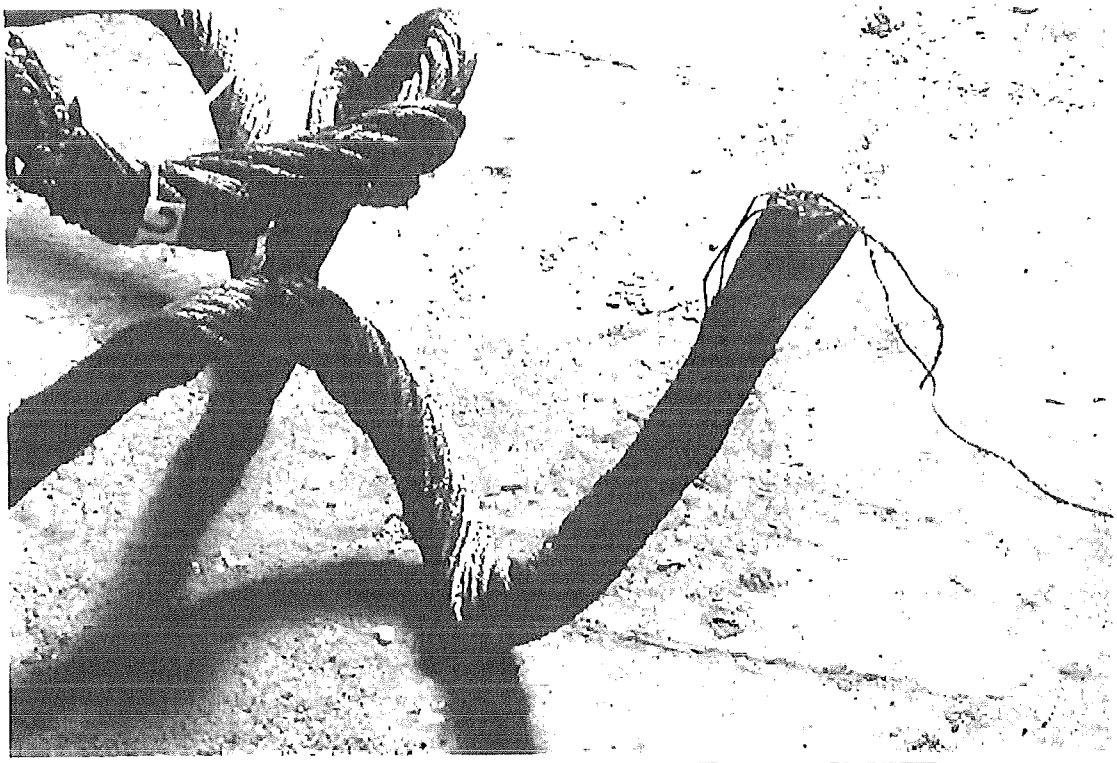
PHOTOGRAPH #4
2' LENGTH OF WIRE ROPE REMOVED FROM CLAMPS

PHOTOGRAPH #5
FRACTURED END OF 2' LENGTH OR WIRE ROPE FROM DRUM

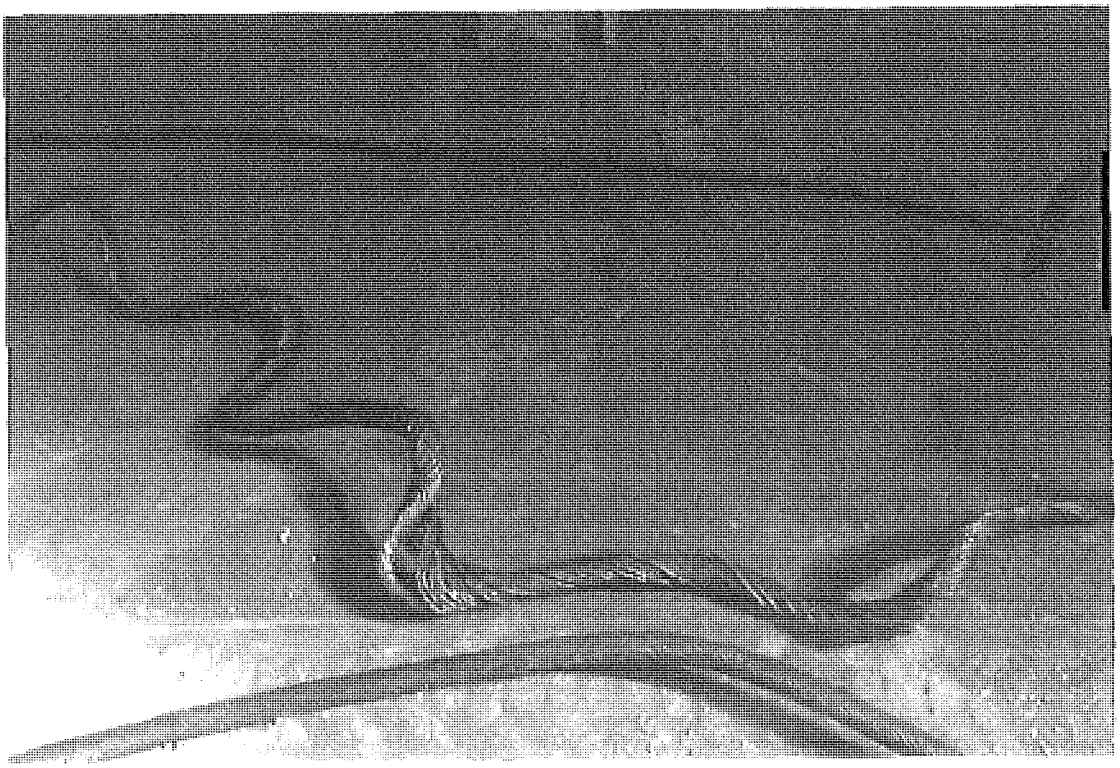
PHOTOGRAPH #6
A SECTION OF WIRE ROPE INSPECTED AT WAREHOUSE

Visual inspection, length and diameter measurements, videotaping and photographing of the multiple lengths of 1 5/8" wire rope and the drive drum hoisting system were conducted on April 3, 2012 at the Bayonne, New Jersey warehouse, Photographs #6 - #9 reflect the typical conditions of the wire rope sections cut and removed from the steel container. These photographs reveal the typical types of damage observed on these wire rope sections. They are comprised of bends, doglegs, kinks, "curling" and recoiling of the wire rope caused from de-reeving and abrasion of the wire rope within the system of sheaves and ultimately breaking from a high impact force at the clamp and pocket on the drive drum.

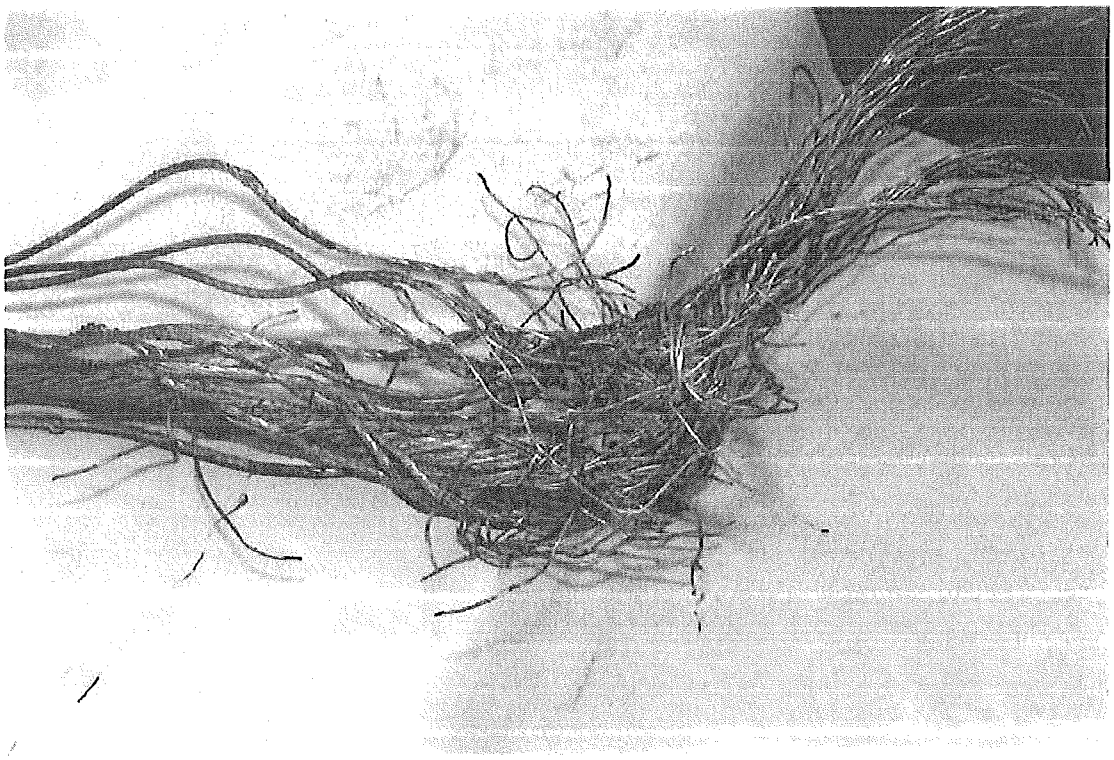
PHOTOGRAPH #10
FAILURE END OF WIRE ROPE OFF THE DRUM

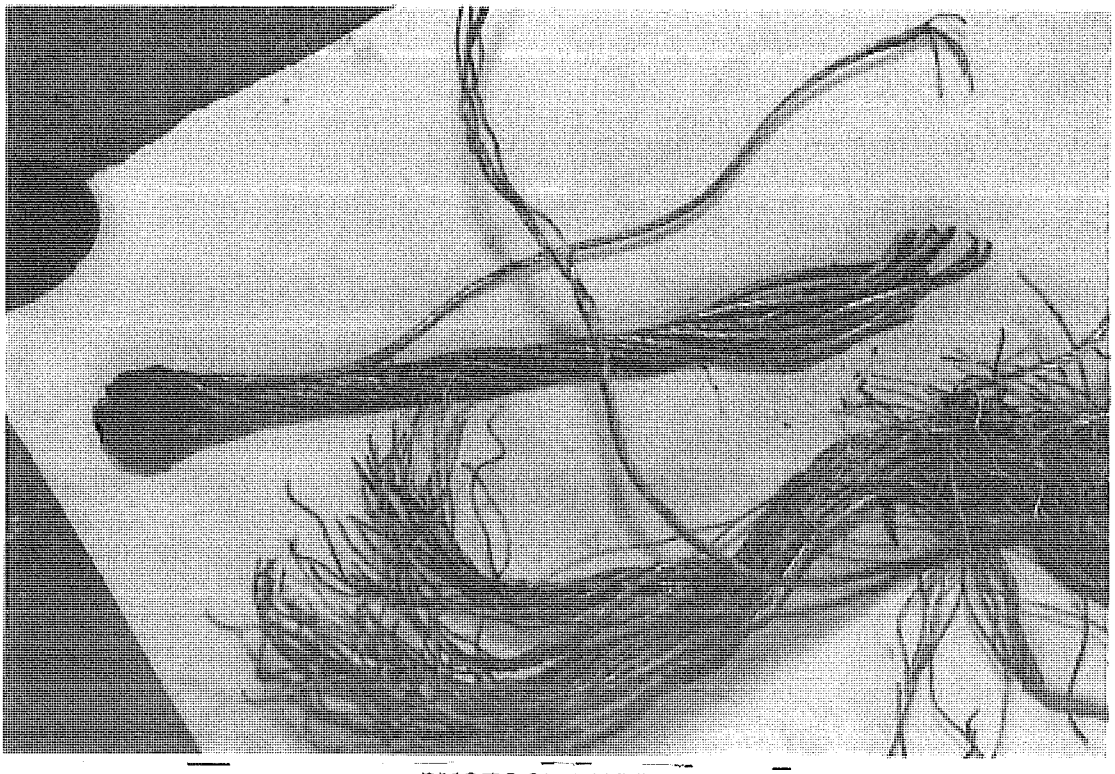
PHOTOGRAPH #11
BOTH ENDS OF WIRE ROPE BREAK

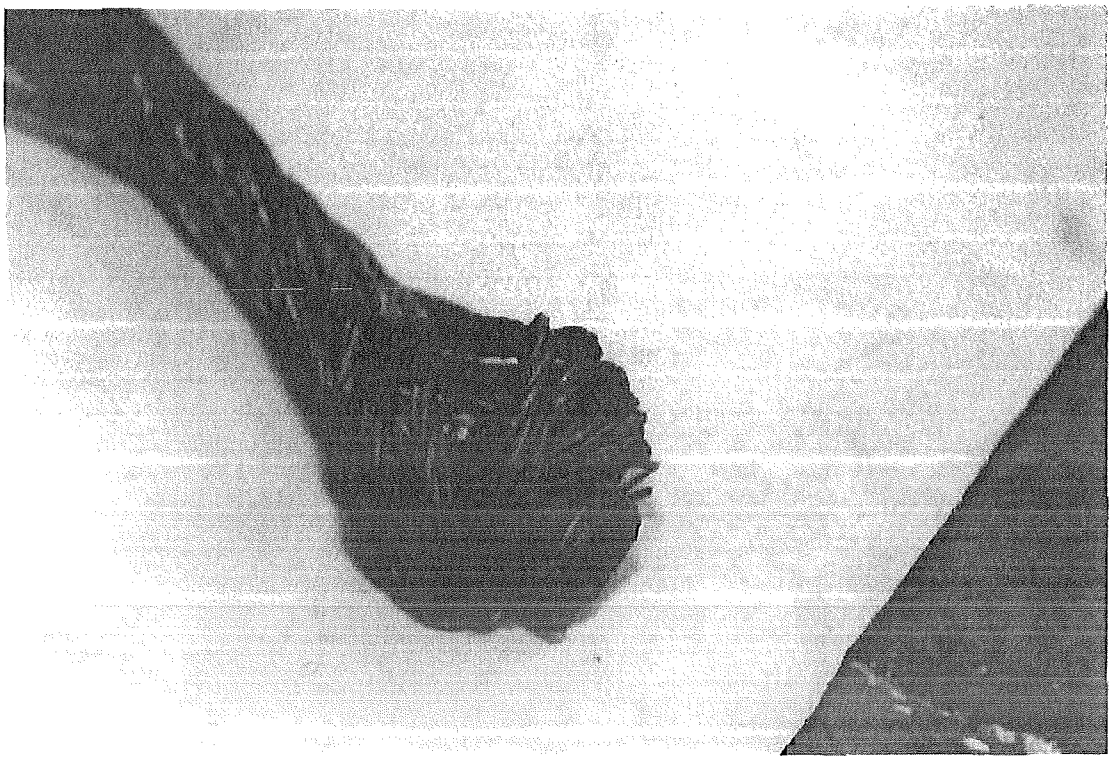
On April 4, 2012, the 10'-5" length of wire rope containing one end of the failure was removed from the warehouse inspection site, along with the short 2' sample containing the other end of the break (Photograph #11). These were then transferred to the laboratories of Lucius Pitkin for failure analysis. A close-up view of the tail end of the wire rope that was located still attached to the drum shows that the IWRC of the wire rope broke at the "knot" formed at the very end of the wire rope (Photograph #12). Inspection of this "knot" placed into the wire rope end reveals that the wire rope had been heated and twisted at this location (Photograph #13).

PHOTOGRAPH #12
"KNOT" FORMED AT TAIL END OF WIRE ROPE ON DRUM

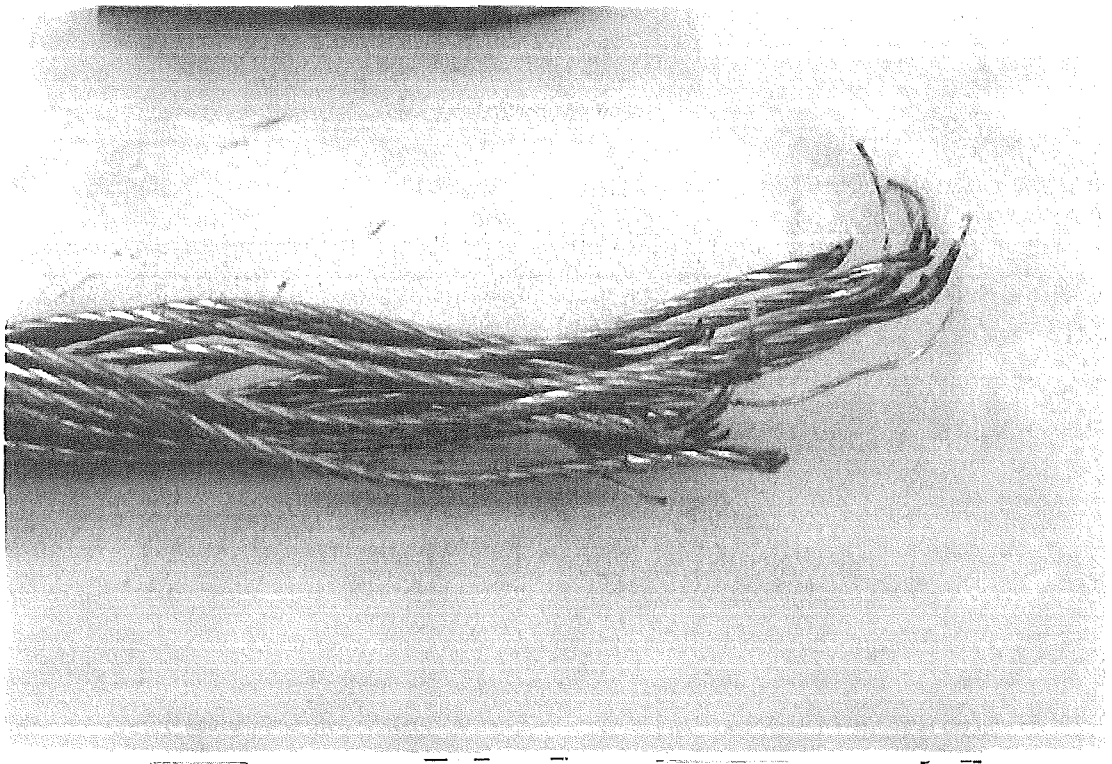
PHOTOGRAPH #13
TWISTED "KNOT" FORMED AT TAIL END OF WIRE ROPE ON DRUM

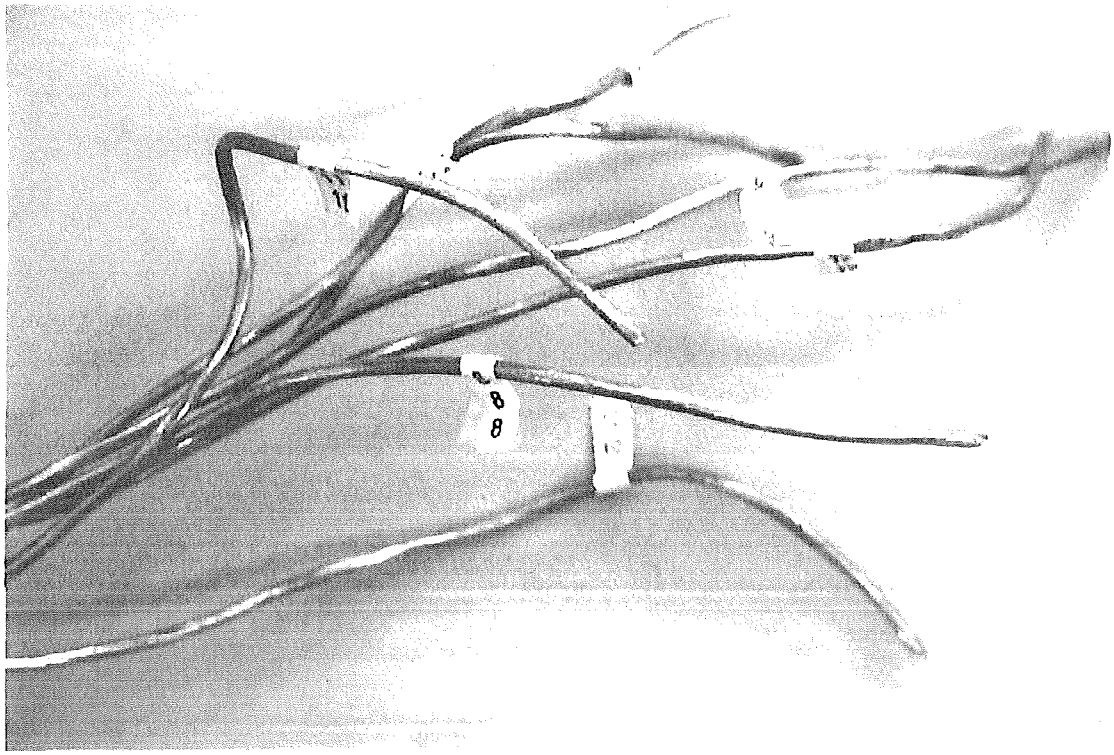
PHOTOGRAPH #15
BROKEN WIRE ENDS OF OUTER WIRE ROPE STRANDS

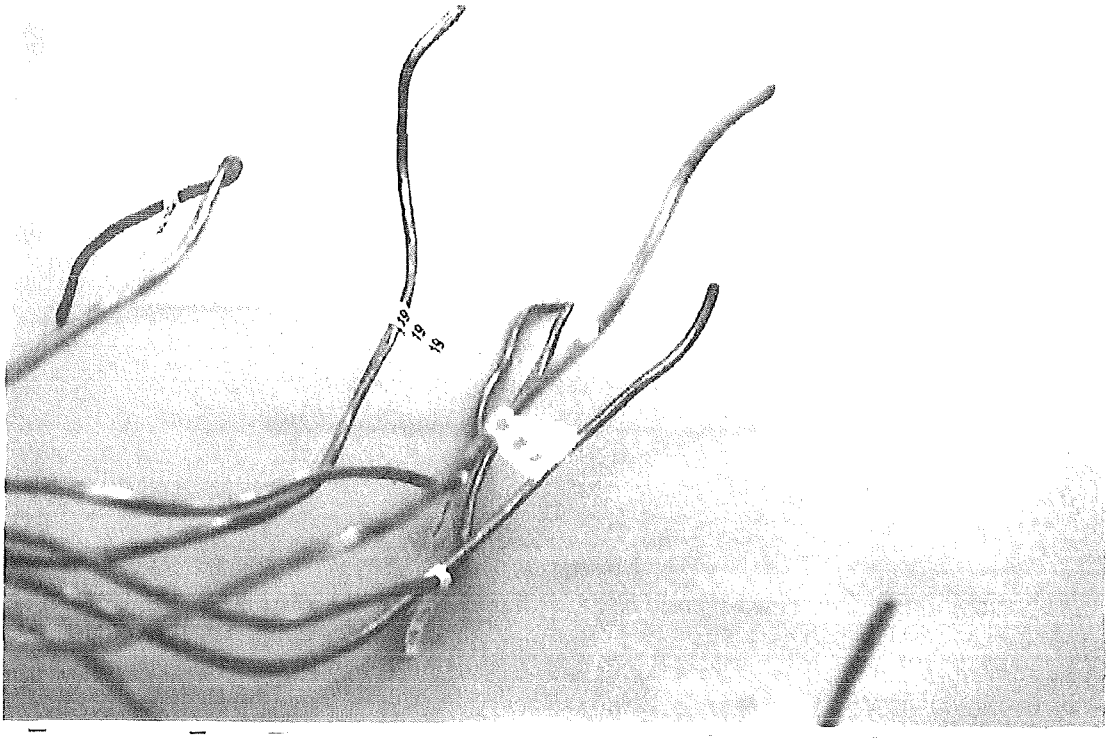
PHOTOGRAPH #16
BROKEN WIRE ENDS OF OUTER WIRE ROPE STRANDS

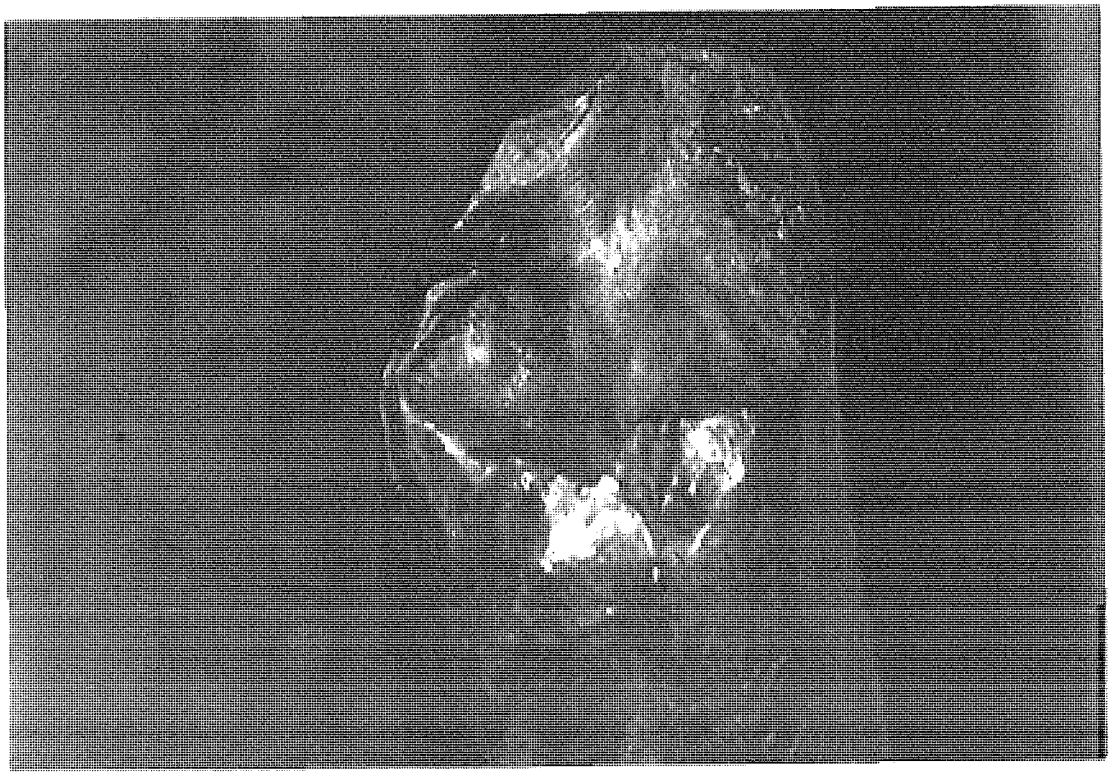
PHOTOGRAPH #17
CRUSHED WIRES AT BROKEN END OF WIRE ROPE

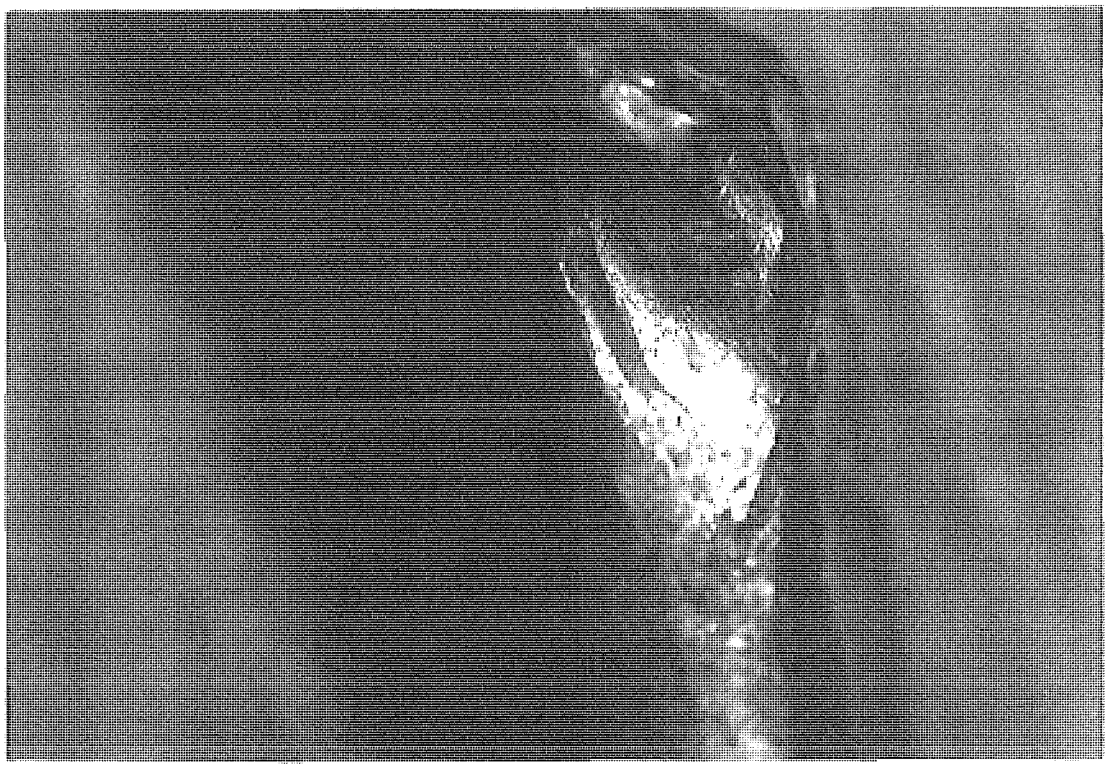
PHOTOGRAPH #18
CRUSHED WIRES AT BROKEN END OF WIRE ROPE

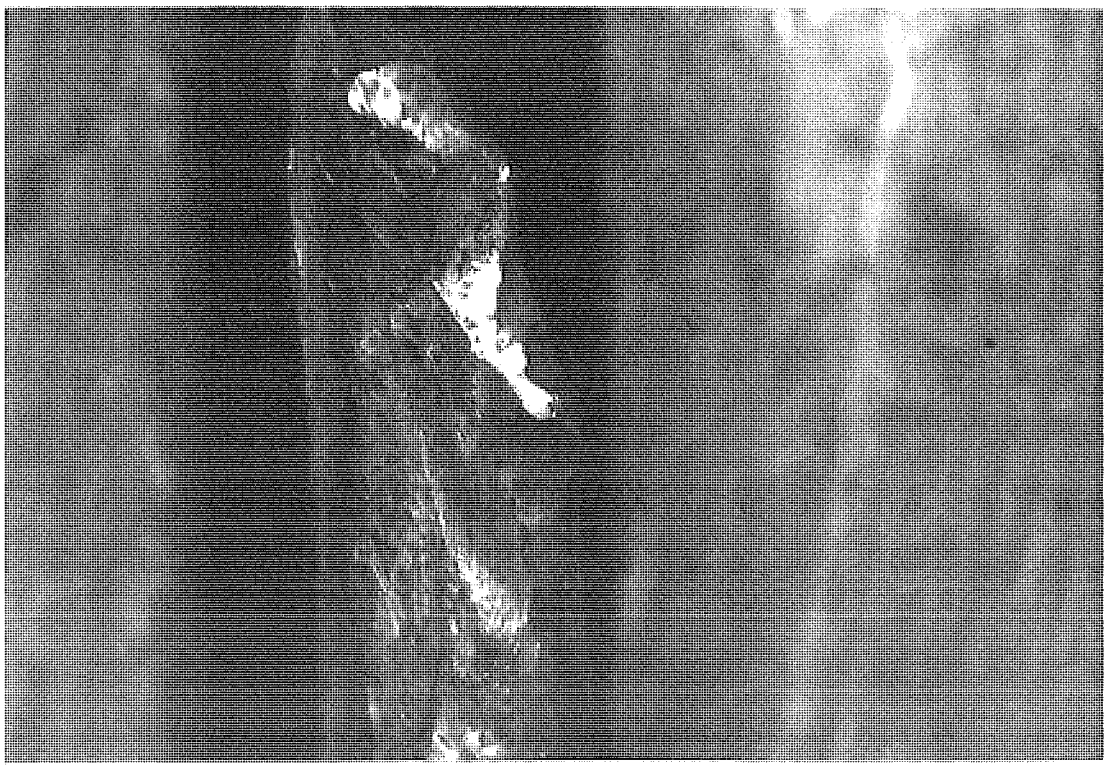
PHOTOGRAPH #19
CRUSHED WIRES AT BROKEN END OF WIRE ROPE

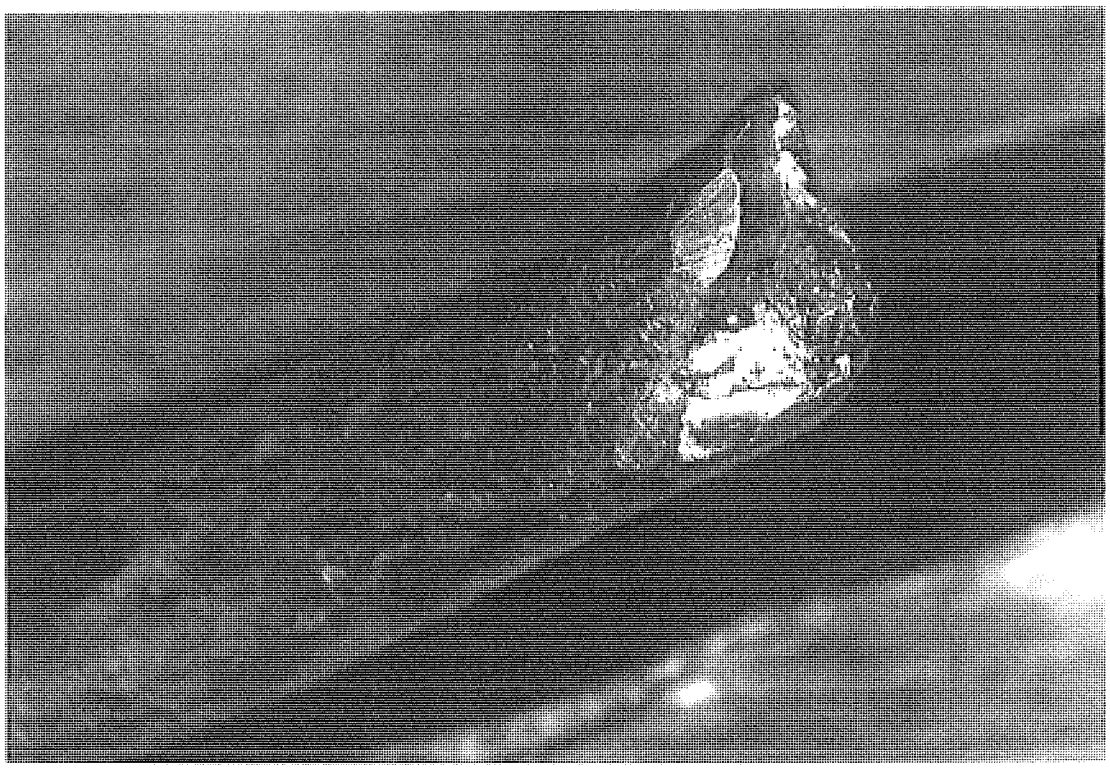
PHOTOGRAPH #20
CUTTING OF WIRES AT BROKEN END OF WIRE ROPE

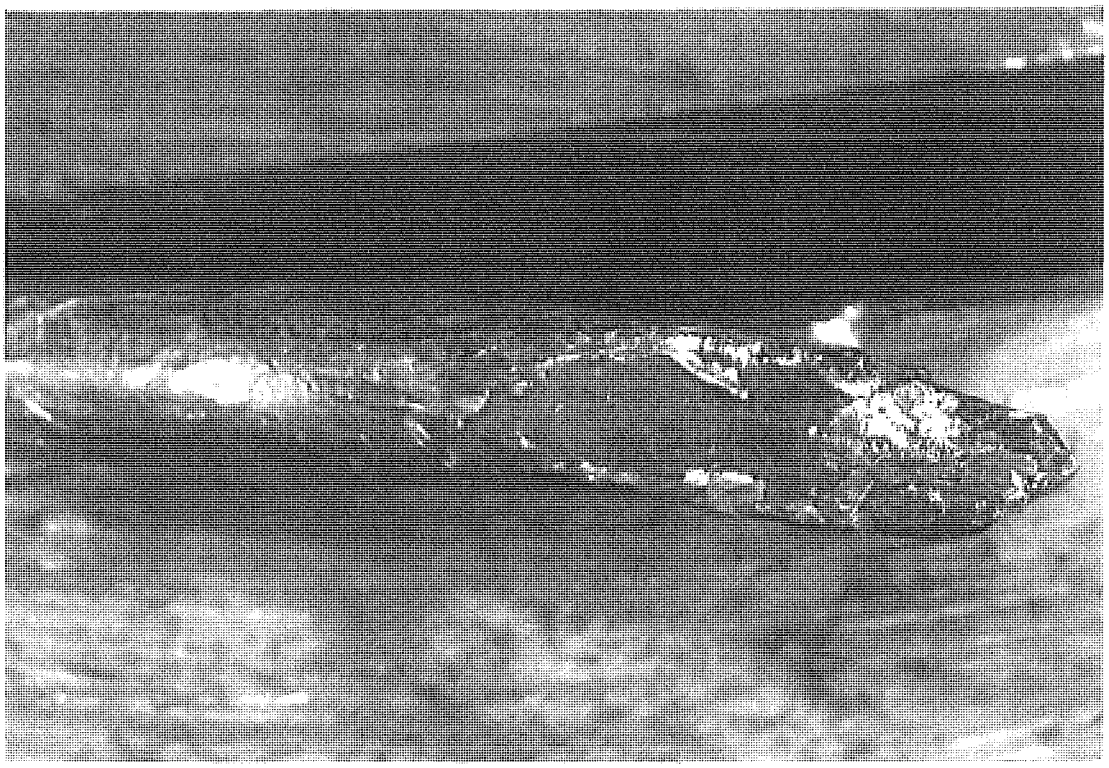
PHOTOGRAPH #22
SHEARING OF WIRES AT BROKEN END OF WIRE ROPE

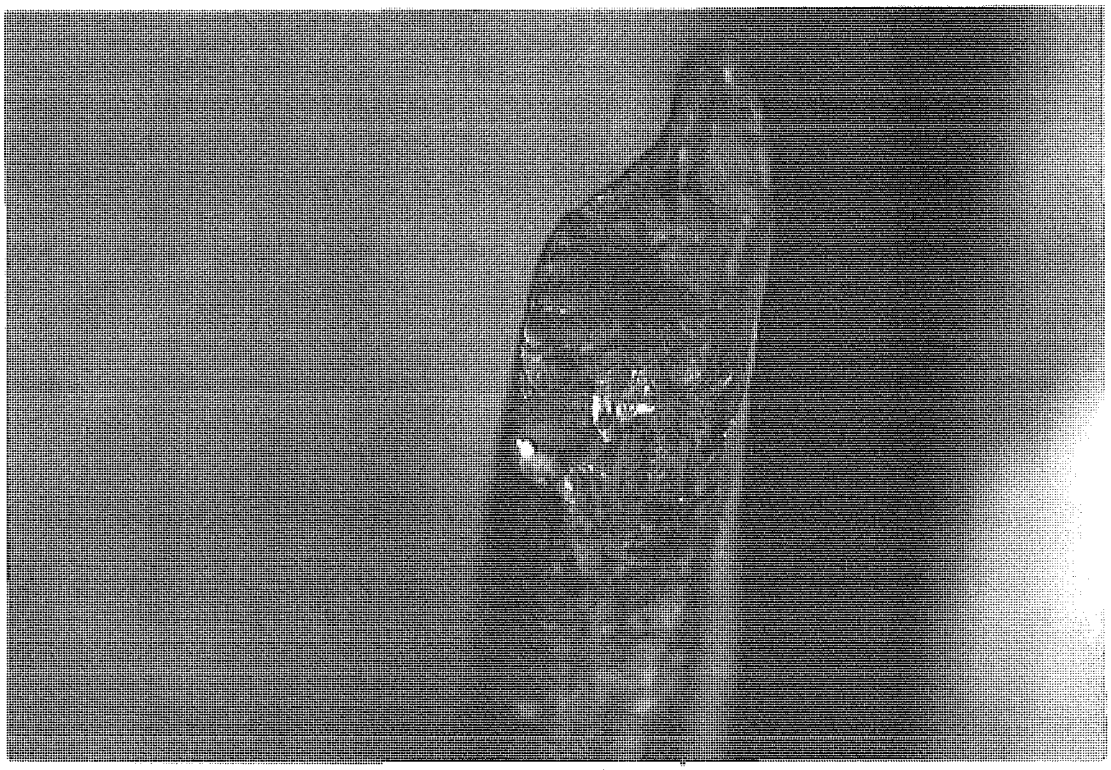
PHOTOGRAPH #24
SHEARING OF WIRES AT BROKEN END OF WIRE ROPE
