List of specific record(s):
Please provide any and all reports generated by Haag Engineering related to the February 16th, 2012 crane accident on the World Trade Center Tower 4 Project, involving the TG1900 Tower Crane SN 76G9-1206C CD 3705

World Trade Center 4500063211
4 World Trade Center
New York, NY
Client File: 4500063211
Haag File: 0212001176-250

The Port Authority of NY and NJ
Port Authority Safety Board
225 Park Avenue South 15th Floor
New York, NY 10003

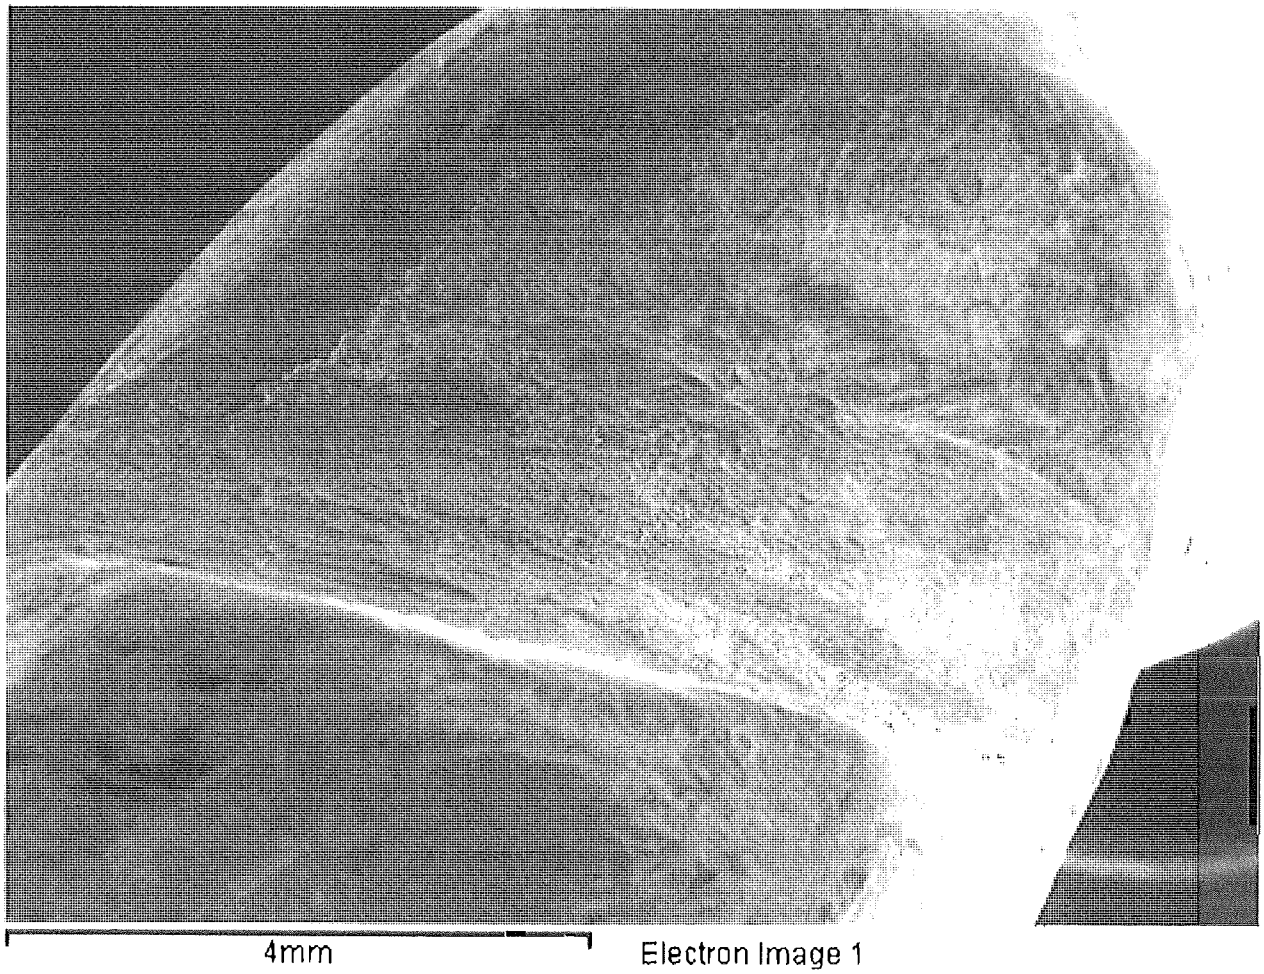
PHOTOGRAPH #26
SEM PHOTO OF DAMAGE AT BROKEN WIRE END

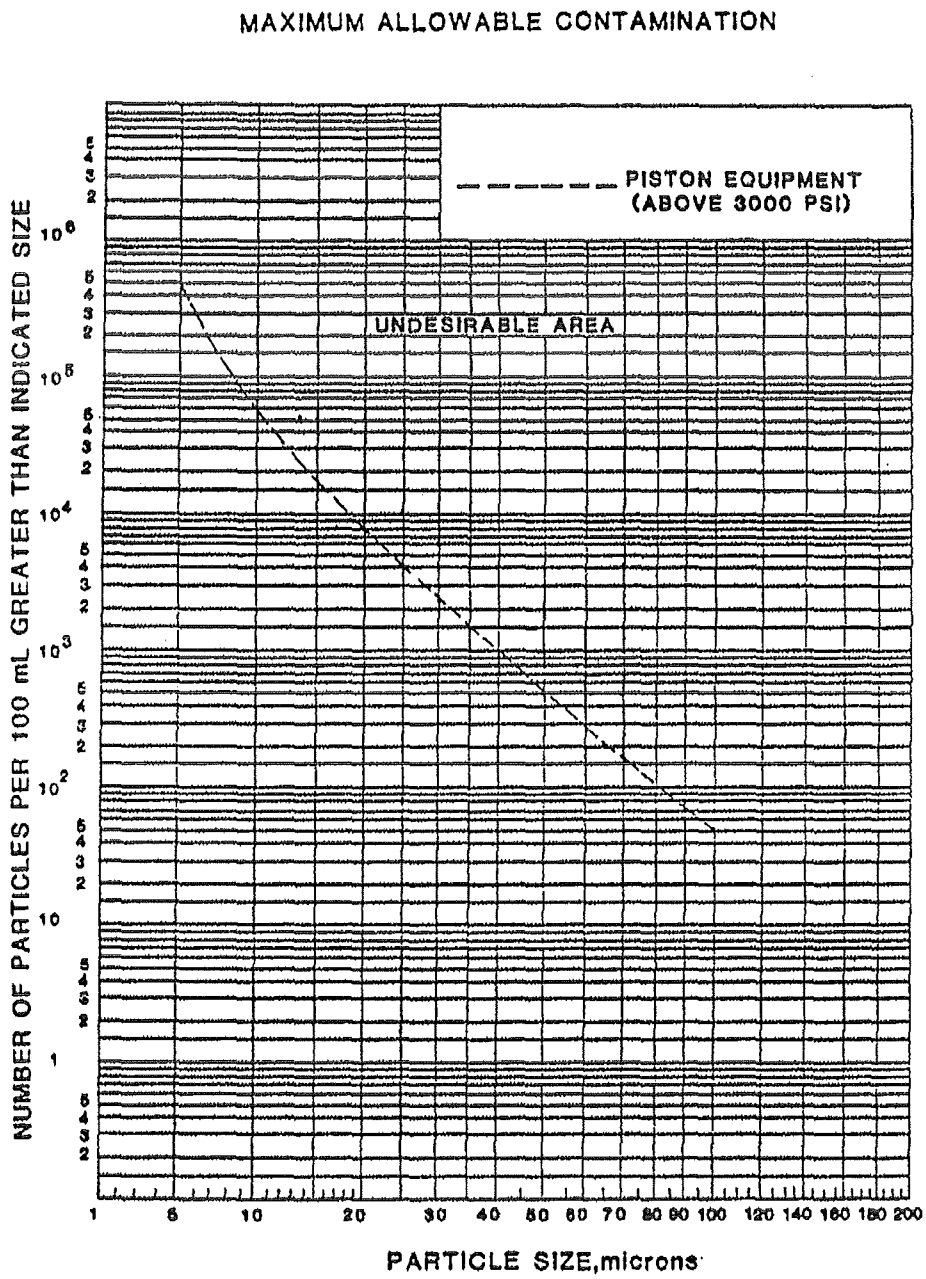
Fig. 5-35
Maximum Allowable Contamination Level

Figure 5-35 shows the maximum allowable contamination level for this model crane. Any count above that level means that the hydraulic oil must be replaced as described earlier in this section of the manual, or filtered using a filter buggy.

The oil must be filtered until the contaminate level is below that shown in Fig. 5-35.

(8) Open butterfly valve and prime pumps and motors as necessary, as described earlier in this section of the manual.
(9) Obtain an oil sample as described earlier in this section of the manual.
(10) If the contamination level is below that shown in Fig. 5-35, put the machine back to work. After 50 hours of operation, change all oil filters.
