List of specific record(s):
I am requesting copies of any and all reports prepared by Haag Engineering of Sugar Land TX, the expert retained to investigate the February 16, 2012 Crane Incident at World Trade Center

World Trade Center 4500063211
4 World Trade Center
New York, NY
Client File: 4500063211
Haag File: 0212001176-250

The Port Authority of NY and NJ
Port Authority Safety Board
225 Park Avenue South 15th Floor
New York, NY 10003

December 21, 2012

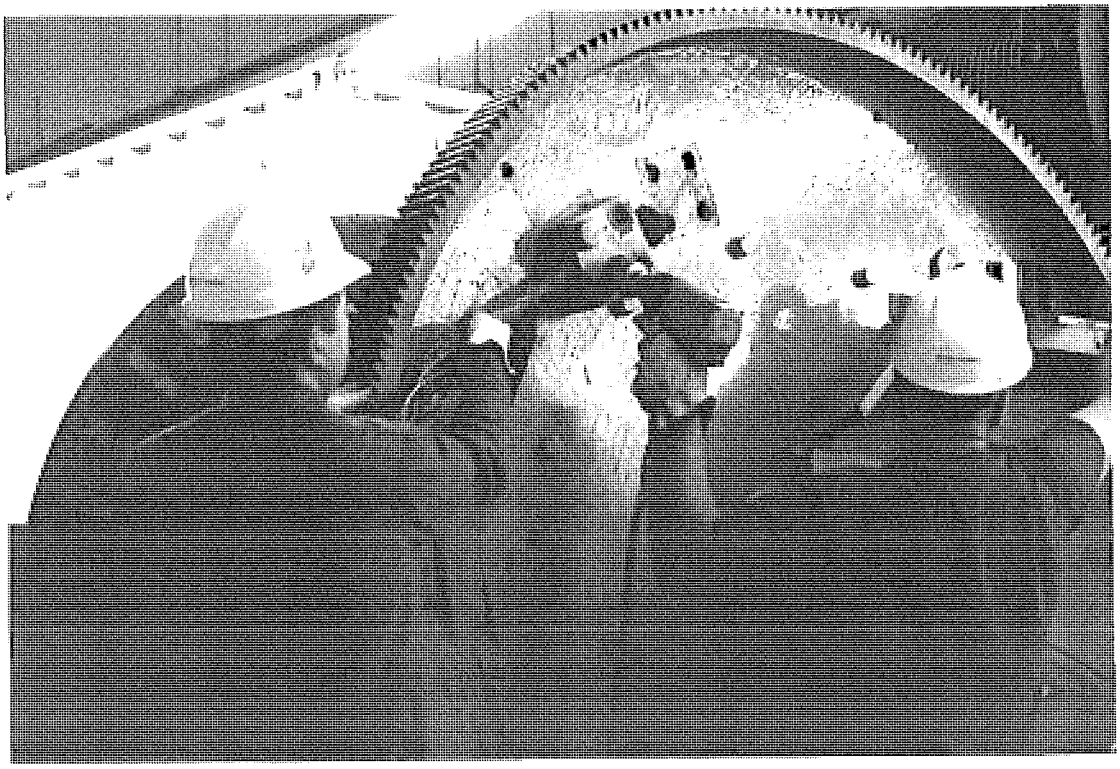
PHOTOGRAPH #3
WIRE ROPE CLAMPS BEING REMOVED FROM DRUM

The length of wire rope containing the end of the failure off of the drive drum is 10'-5" long with the failure end shown in Photograph #10. This failure end of the wire rope reveals that all 16 outer strands broke at the first set of clamps at the connection point on the drum (Photograph #3). The IWRC, or core of this wire rope, broke away from this location at approximately the very end of the wire rope positioned within the drum clamps (Photograph #4).
